Laboratory Testing of Handpumps for Developing Countries,
World Bank Technical Paper #19 from the Rural Water
Supply Handpumps Project

Rural Water Supply Handpumps Project

Laboratory Testing of Handpumps for Developing Countries: Final Technical Report

Consumers' Association Testing and Research Laboratories

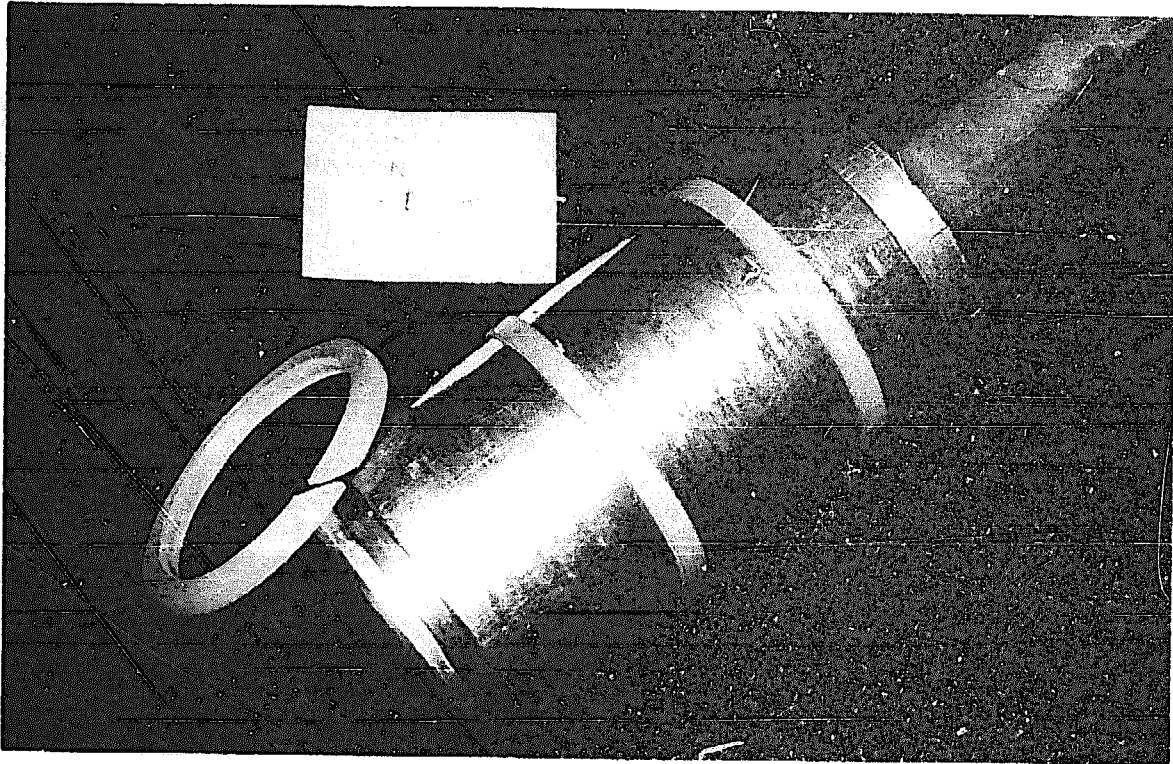
Polyethylene seals made to replace the original leather seals

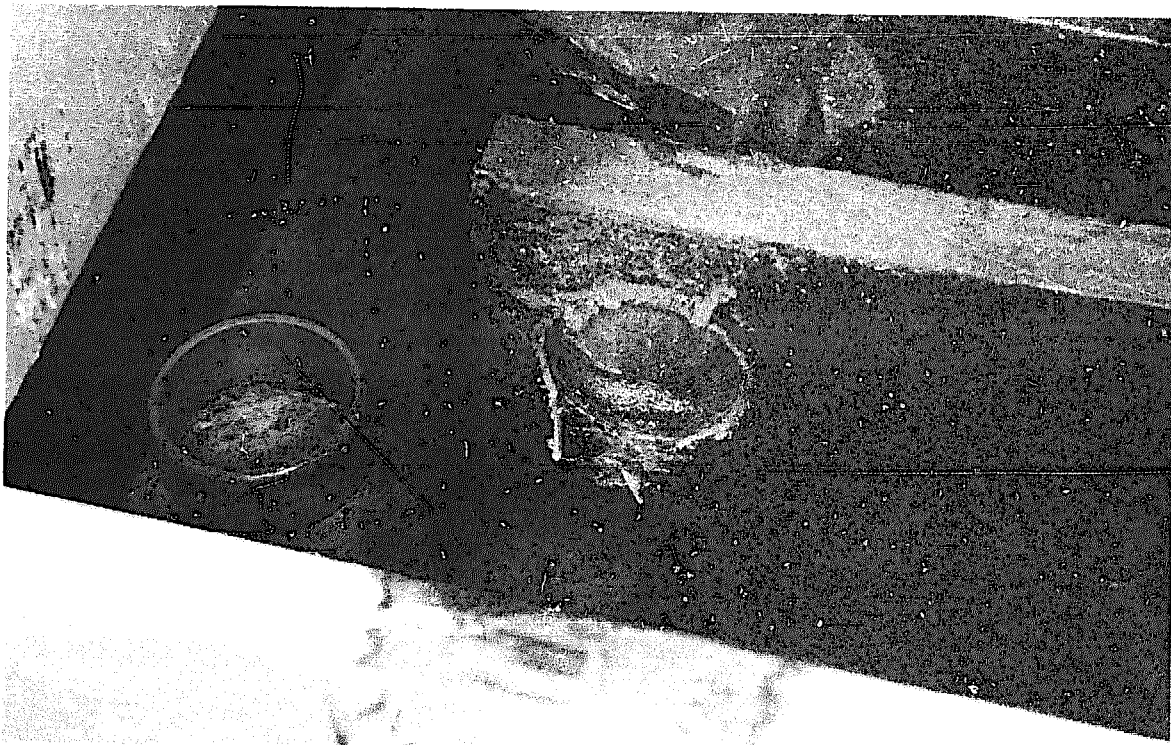
Handle bearings after 1529 hours

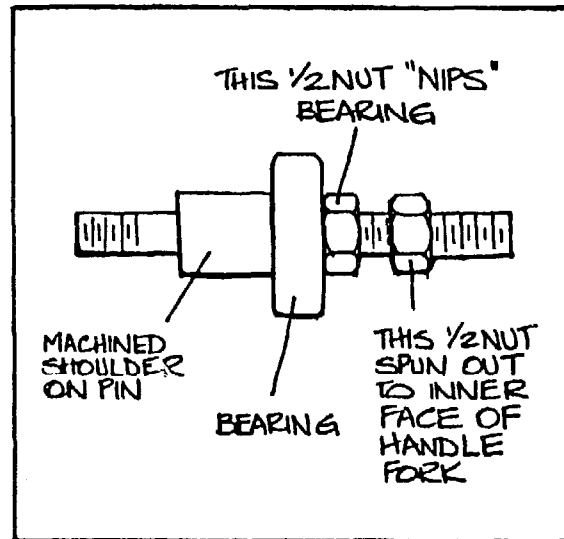
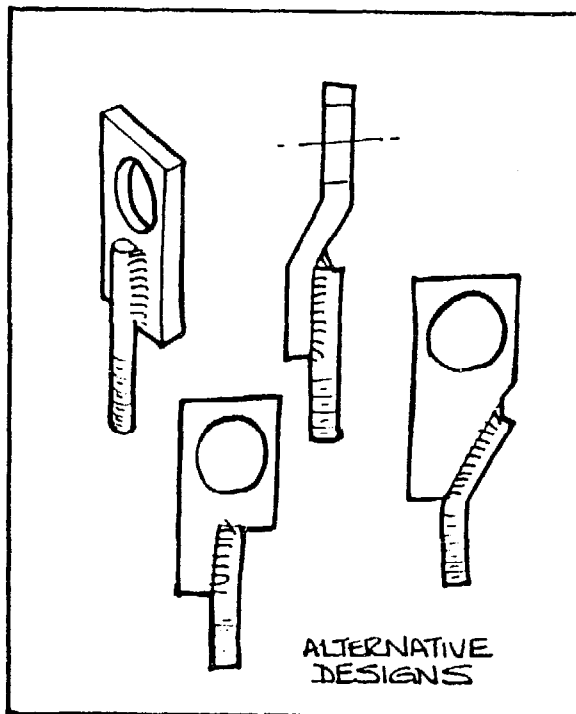
The hanger need not be rounded off at the top and could be designed to eliminate the need for the central slot. See illustration, left.

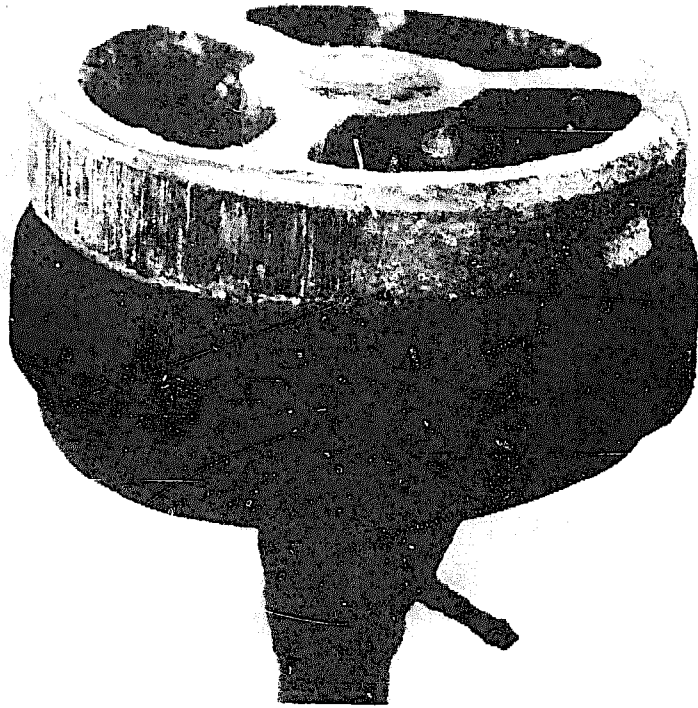
Plunger at end of endurance test

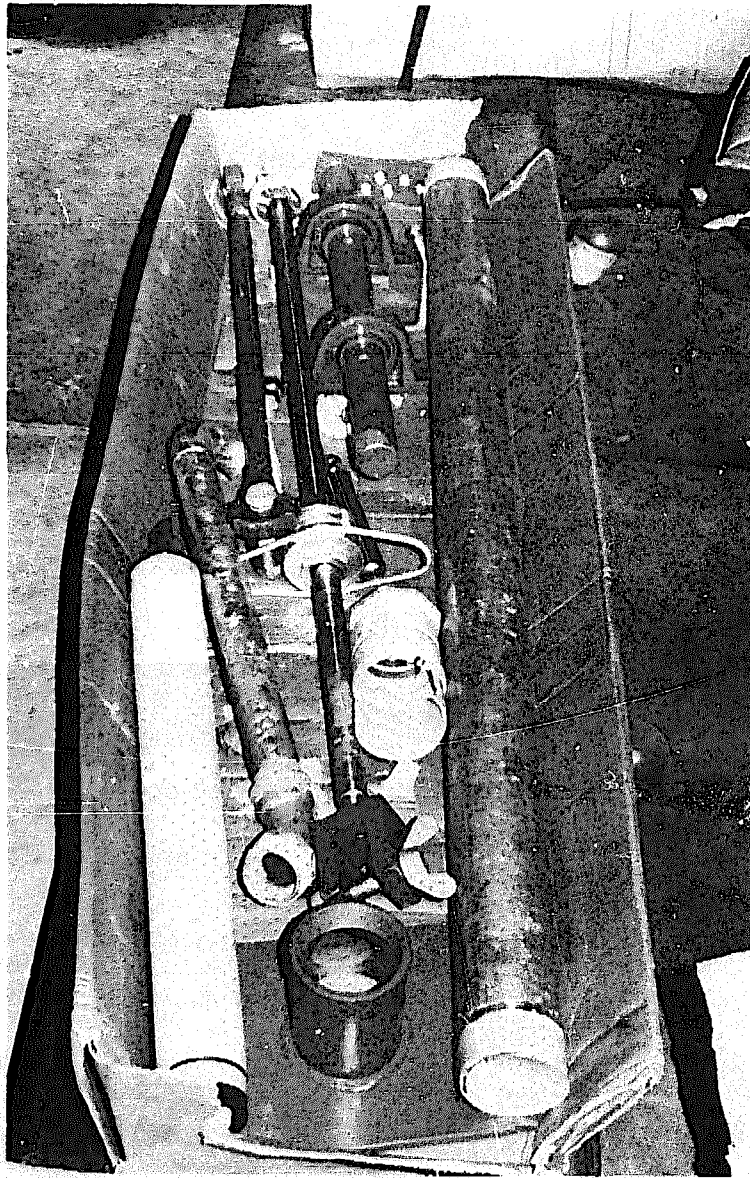
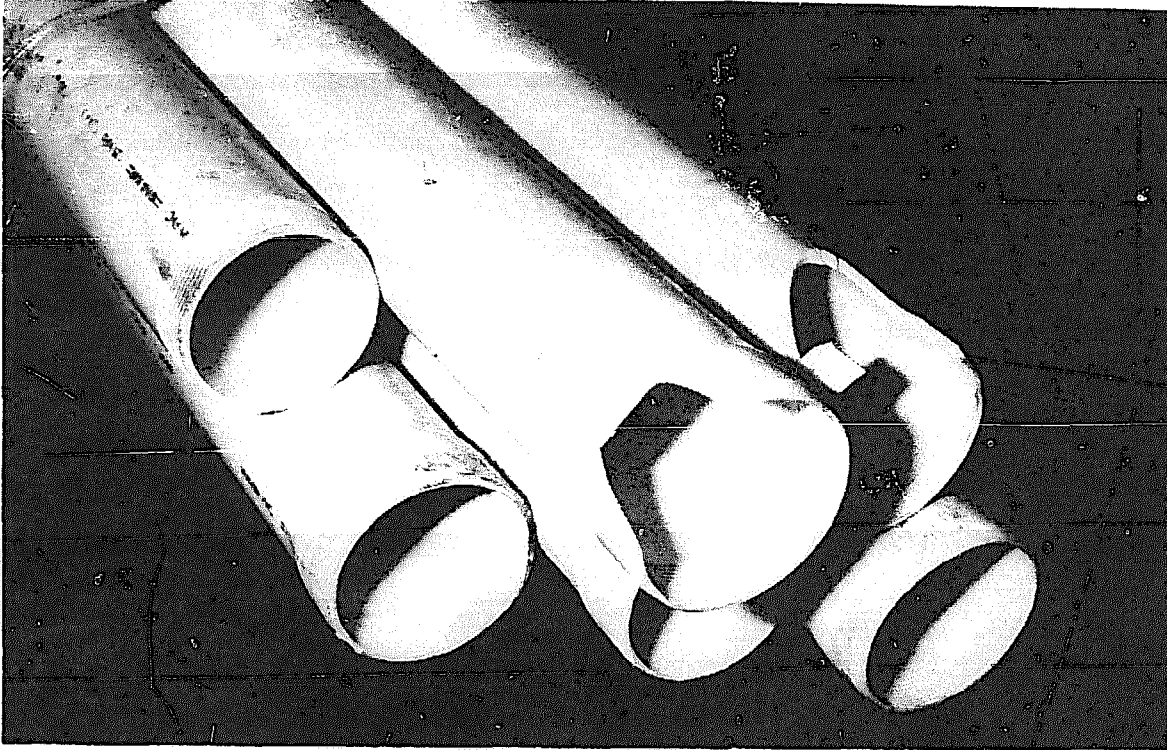
Although the wooden case was satisfactory, the cardboard boxes were unsuitable for the amount of weight put in them, and the components were loose inside. Several components were broken or damaged. The packaging of the pipes was completely unsuitable, four of the six pipes bundled together were damaged in transit.

Inadequate Packaging in Cardboard Boxes

Broken Pipes

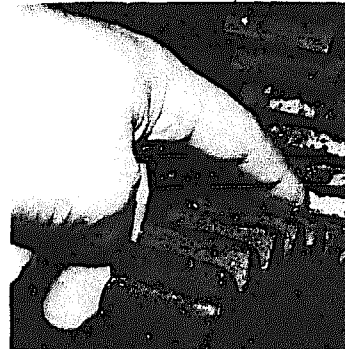
The quadrant and rack present a potentially dangerous finger trap, particularly in view of the large mechanical advantage of the handle. See photograph, right.

In response, the manufacturer has modified the pumpstand by adding a cover plate shielding the quadrant from above, and by reducing the lift of the plunger valve. The cover plate provides a good deal of protection but can easily be removed and left off. The suggested change to the casting is therefore preferable.

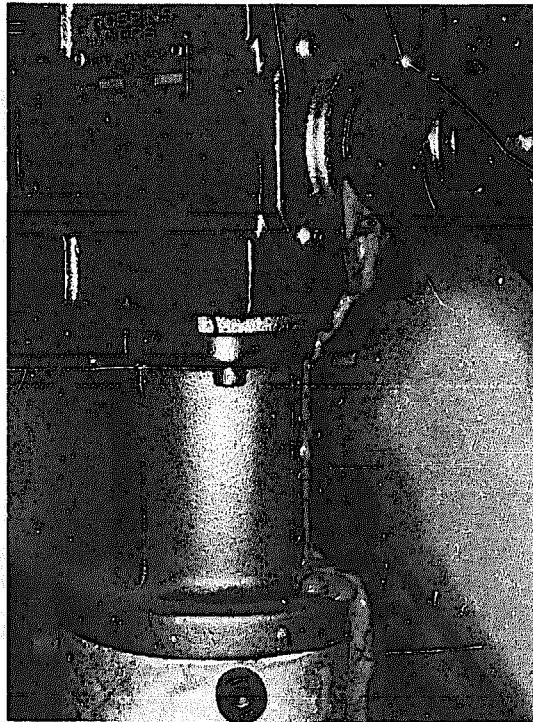
Some grease leaked out of the gearbox through one of the handle bearing seals, see photograph, right, but the final inspection revealed that plenty of grease remained in the gearbox.

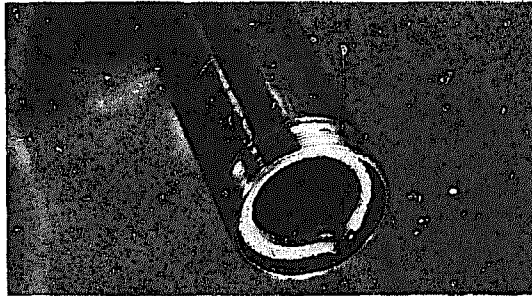
the plunger seals, caused by wrongly-sized sealing cords - see photograph, below. The cords appeared to have been cut to length to suit the machined grooves in the plunger, and with butt joints - as a result they were a poor fit in the cylinder in both samples.

Spare cord had been supplied with the pumps, and new sealing rings were cut to suit the cylinder bore, and with angled, scarf joints. This markedly improved the pump efficiency, from 37% to 71% at 25 metres depth.

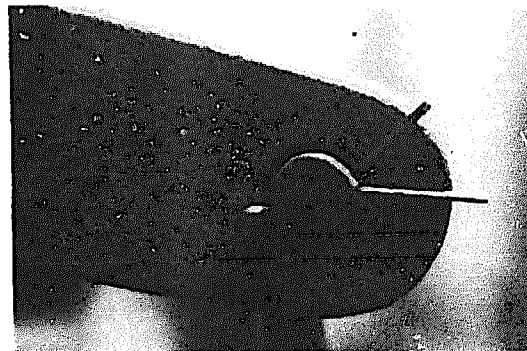
For example, the holes for the handle pivot pins are deliberately drilled oversize to avoid any problems arising from misalignment - see photograph, right.

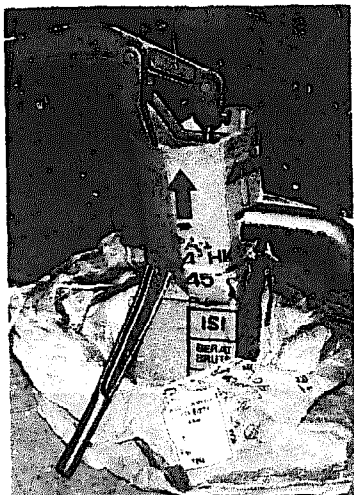
2.1 Packaging The packaging in which these pumps were delivered was very unsuitable.

Each pump was wrapped in pieces of corrugated cardboard and then in a plastic sack - see photograph, left.

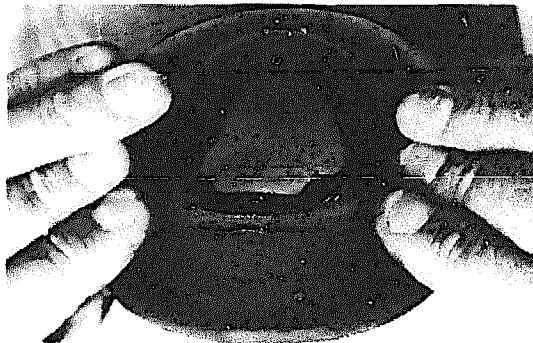
- 1. Pump Body and Handle
 - (a) Cylinder bore in good condition showing no signs of wear
 - (b) Fulcrum pins and bushes all worn, though pump still working
 - (c) Handle no longer contacts bottom stop (because of wear in fulcrum bearings) but fouls on connecting rod eye
- 2. Plunger
 - (a) Plunger valve noticeably worn though still serviceable
 - (b) Some cracks in upper surface of cup washer though still watertight - see photograph, below

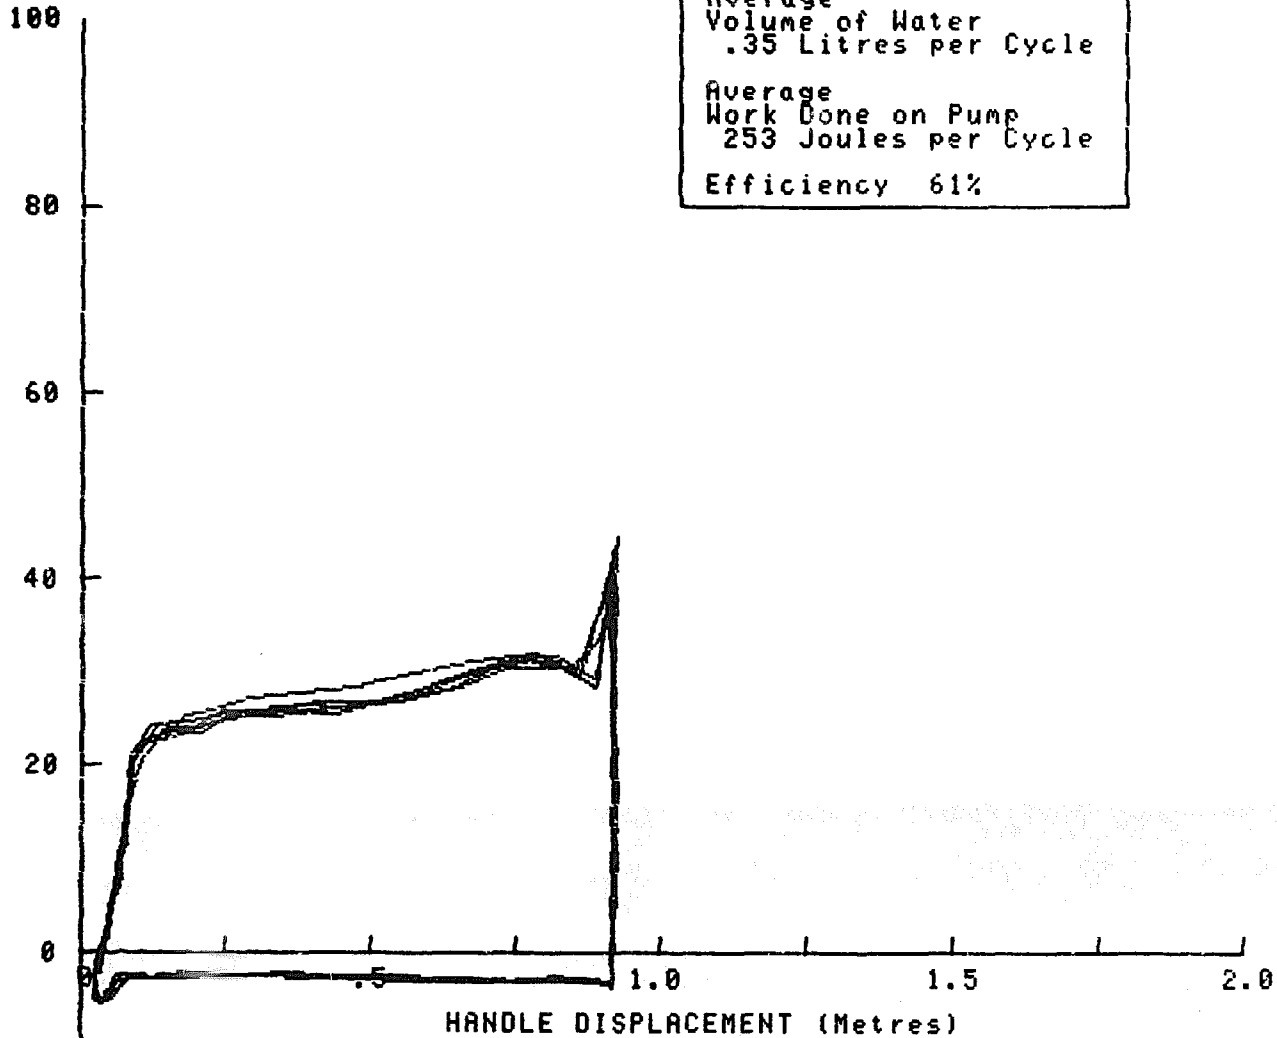
The diagrams illustrate the effects of wear in the pumpstand rack and quadrant:
(a) greater handle displacement for the same volume flow
(b) increased frictional losses, particularly at the start of the return stroke.

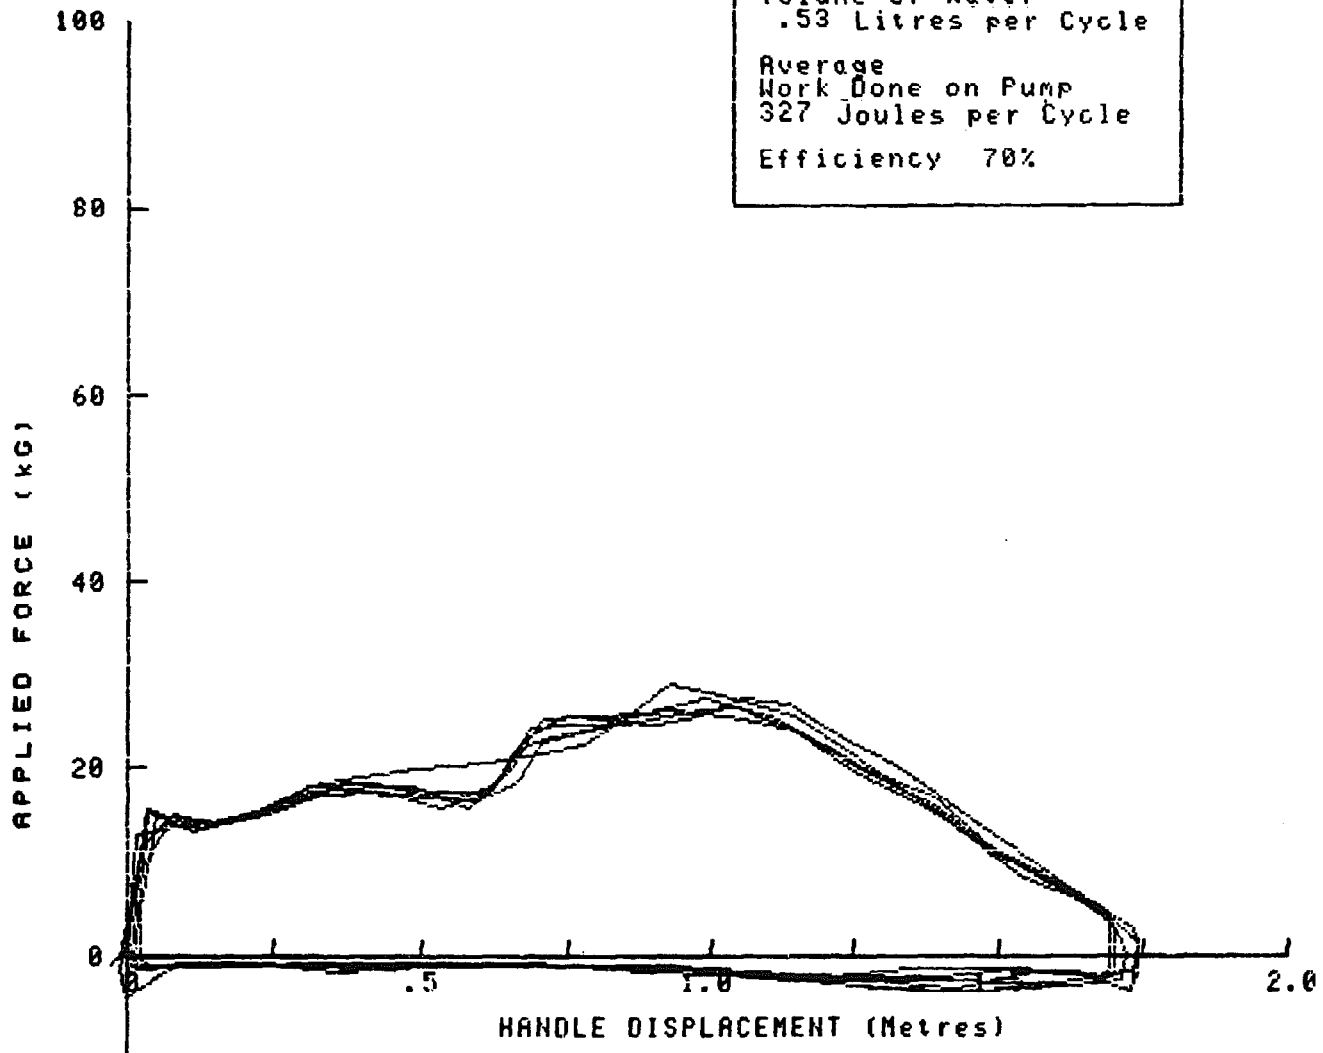
The irregularities on the power stroke are probably caused by variations in the linkage friction due to the wear which has taken place in the linkage mechanism.

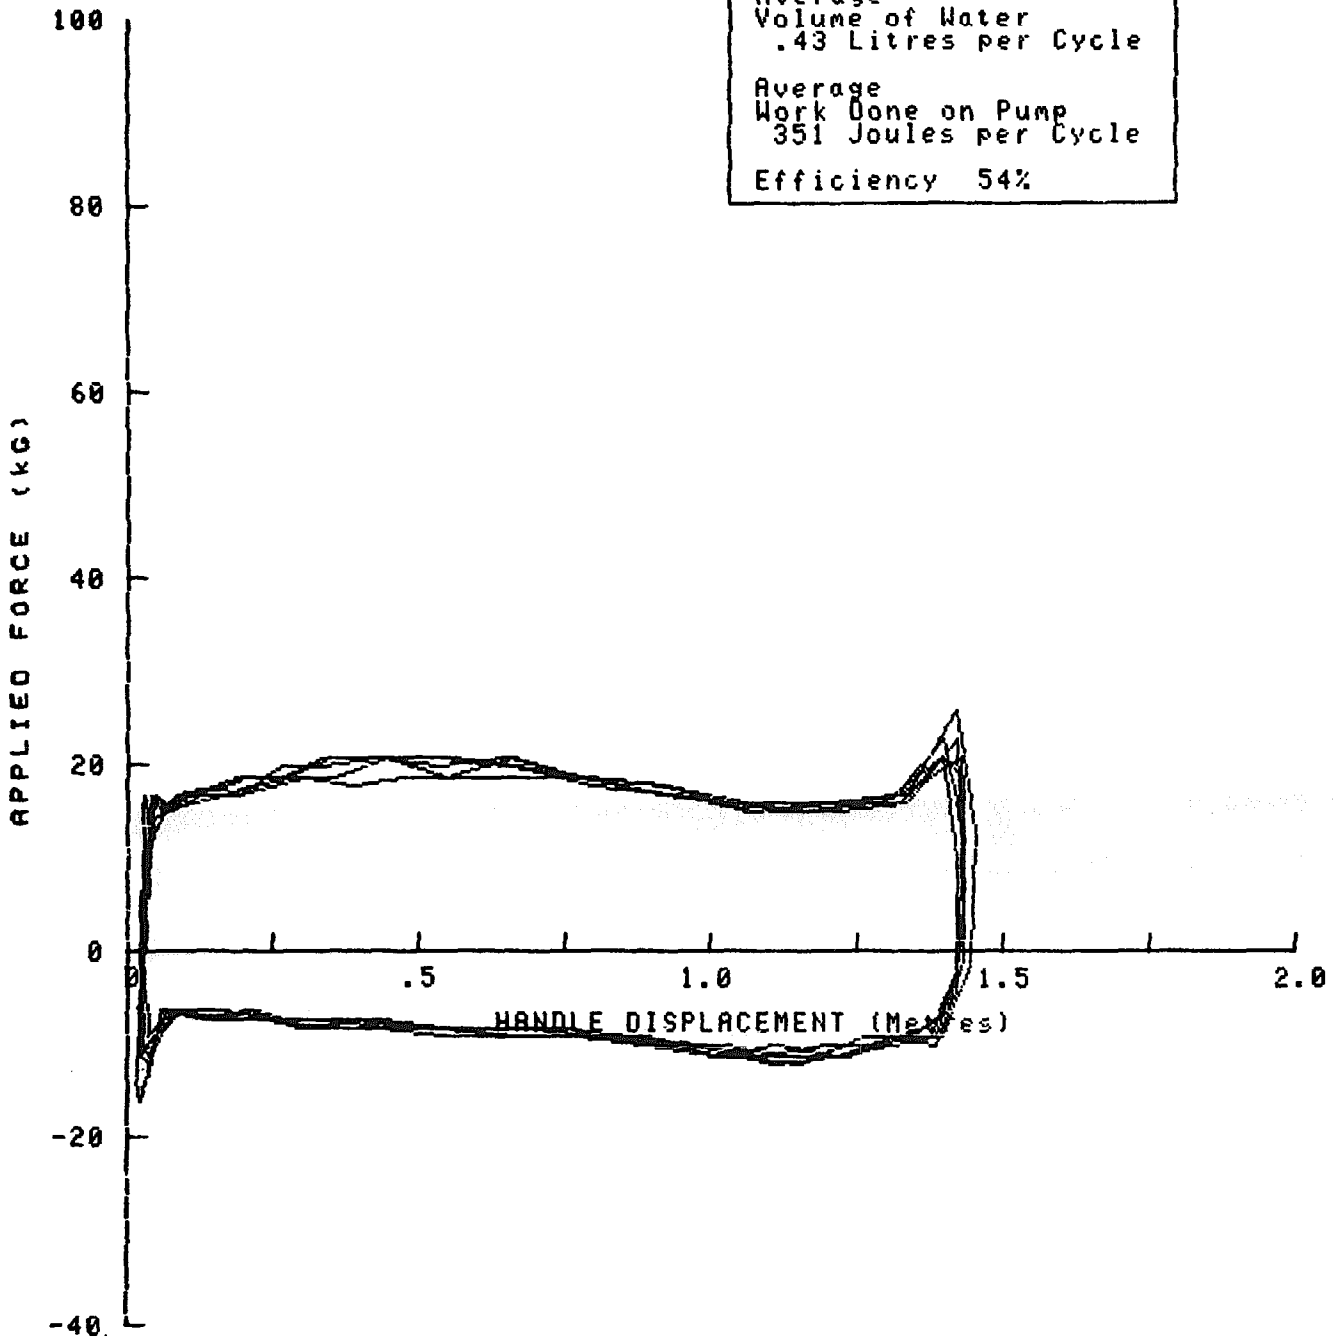
PUMP PERFORMANCE after endurance CODE D Nepta

The results show that the work done on the handle increased by over 50% after endurance, with a small increase in volume flow. Friction had therefore increased considerably, probably as a result of the failure of the upper plunger seal.

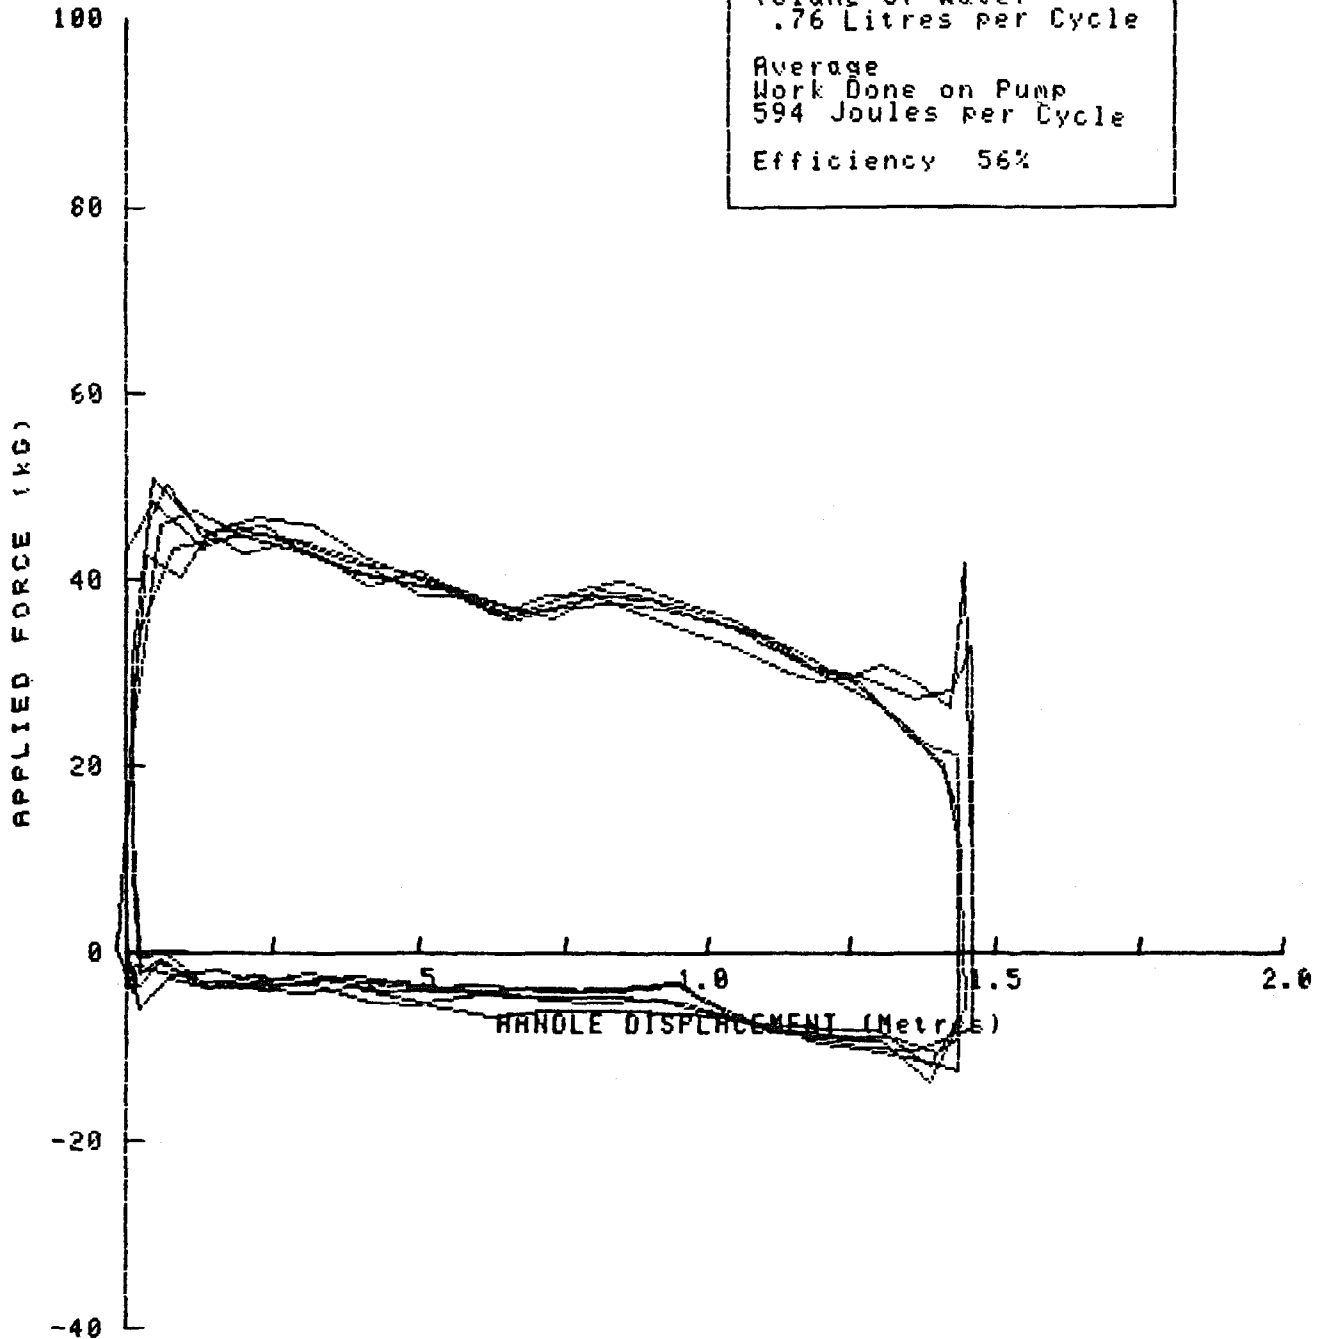
PUMP PERFORMANCE after ENDURANCE CODE E Kenya

Differences between the profiles of the curves before and after endurance are the result of severe wear at the handle pivot.

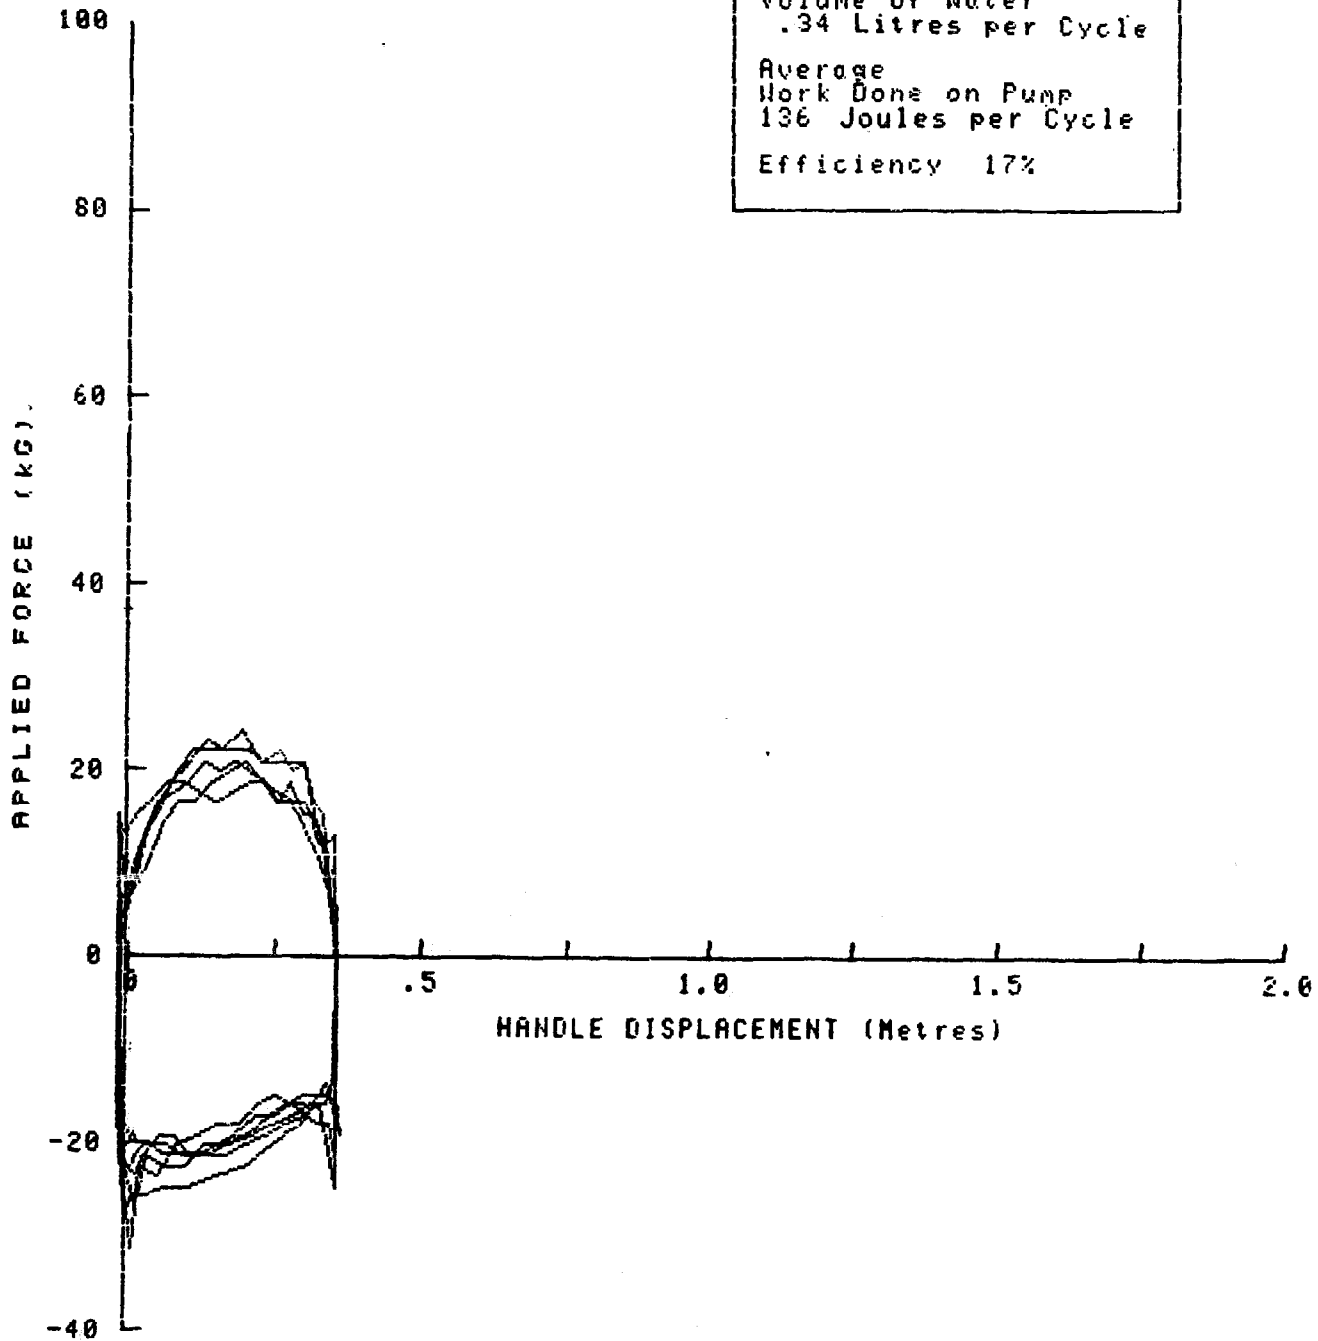
PUMP PERFORMANCE after ENDURANCE
CODE H Ethiopia Type BP50

As this pump discharges on the lifting stroke, the power stroke is below the horizontal coordinate. The reduction in force on the power stroke after endurance shows the leakage past the plunger.
