Installation of a Solar Distillation Plant on
Ile de la Gonave, Haiti Internal Report No. I.67

INSTALLATION OF A SOLAR DISTILLATION PLANT
ON ILE DE LA GONAVE, HAITI

Internal Report No. I.67

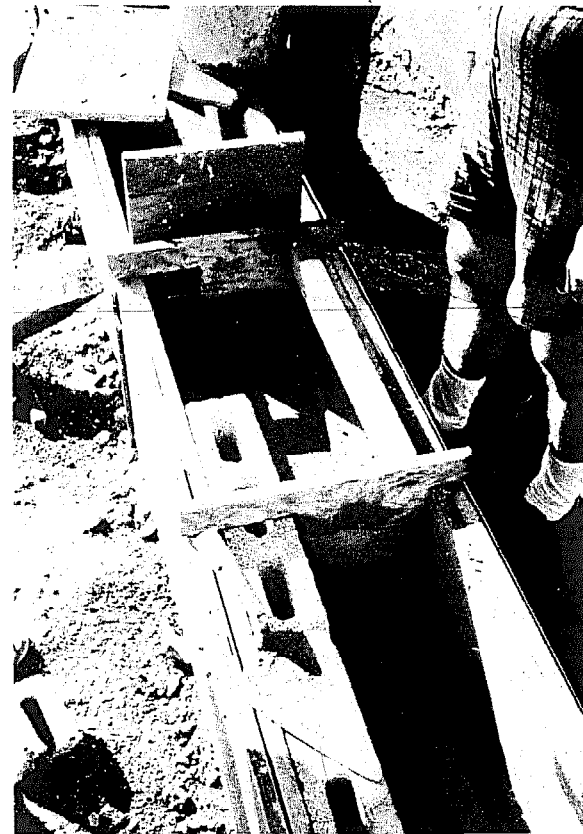
Fig 2: Special form used for positioning of concrete blocks and for moulding mortar and concrete into the shape of the gutters

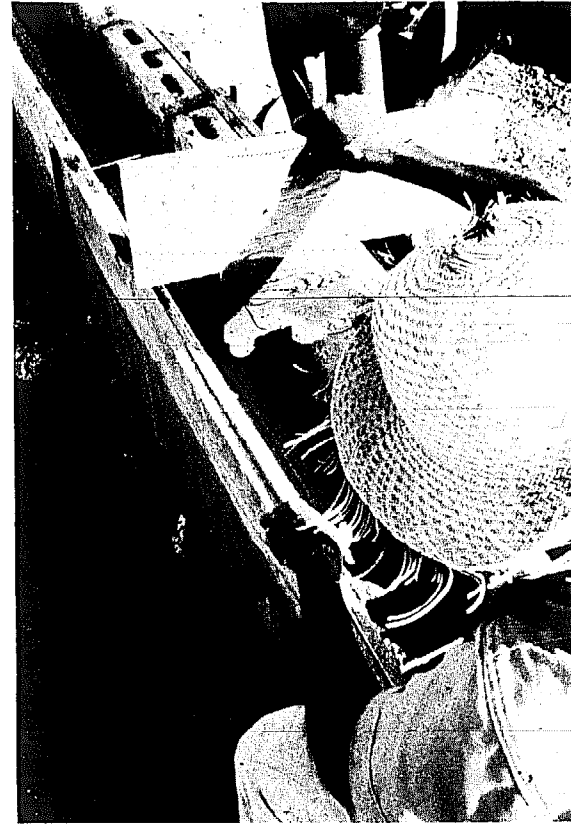
Fig 4: Specially contoured wood and metal backed mould used in forming the fine finish on the gutters

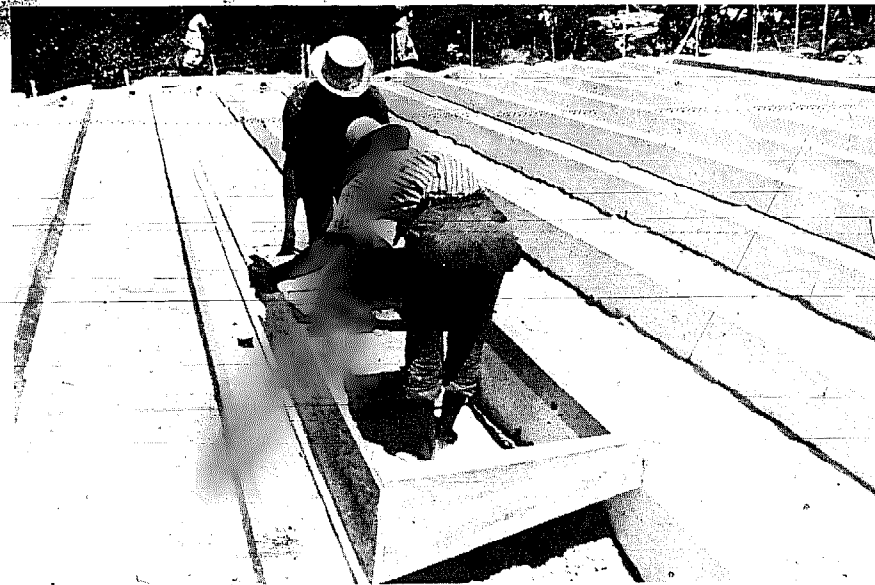
Fig 6: Finished curb and end walls with basin fill. The wooden frame is the guide used in levelling the basin fill in each of the twelve 6 foot long ponds that form one bay

The area between the curb walls was covered with a layer of beach sand up to a depth of four inches below the proposed level of the butyl rubber liner. The length of each basin was then split up into a number of six-foot sections. A large wooden frame (see Figure 6), some 7 feet in length, was built with appropriately sloping guides such that the sand in each of these six-foot sections could be levelled. This first layer of beach sand was well tamped and on top of this went a two-inch layer of dried coffee husks to act as insulation. This layer was levelled using the same wood frame with the levelling boards raised two inches. A second two-inch layer of beach sand was placed on top of the insulation, and again the area was well tamped. A series of two-inch high weirs were built from the sand, at the end of each six-foot section.
