Laboratory Testing of Handpumps for Developing Countries,
World Bank Technical Paper #19 from the Rural Water
Supply Handpumps Project

Rural Water Supply Handpumps Project

Laboratory Testing of Handpumps for Developing Countries: Final Technical Report

Consumers' Association Testing and Research Laboratories

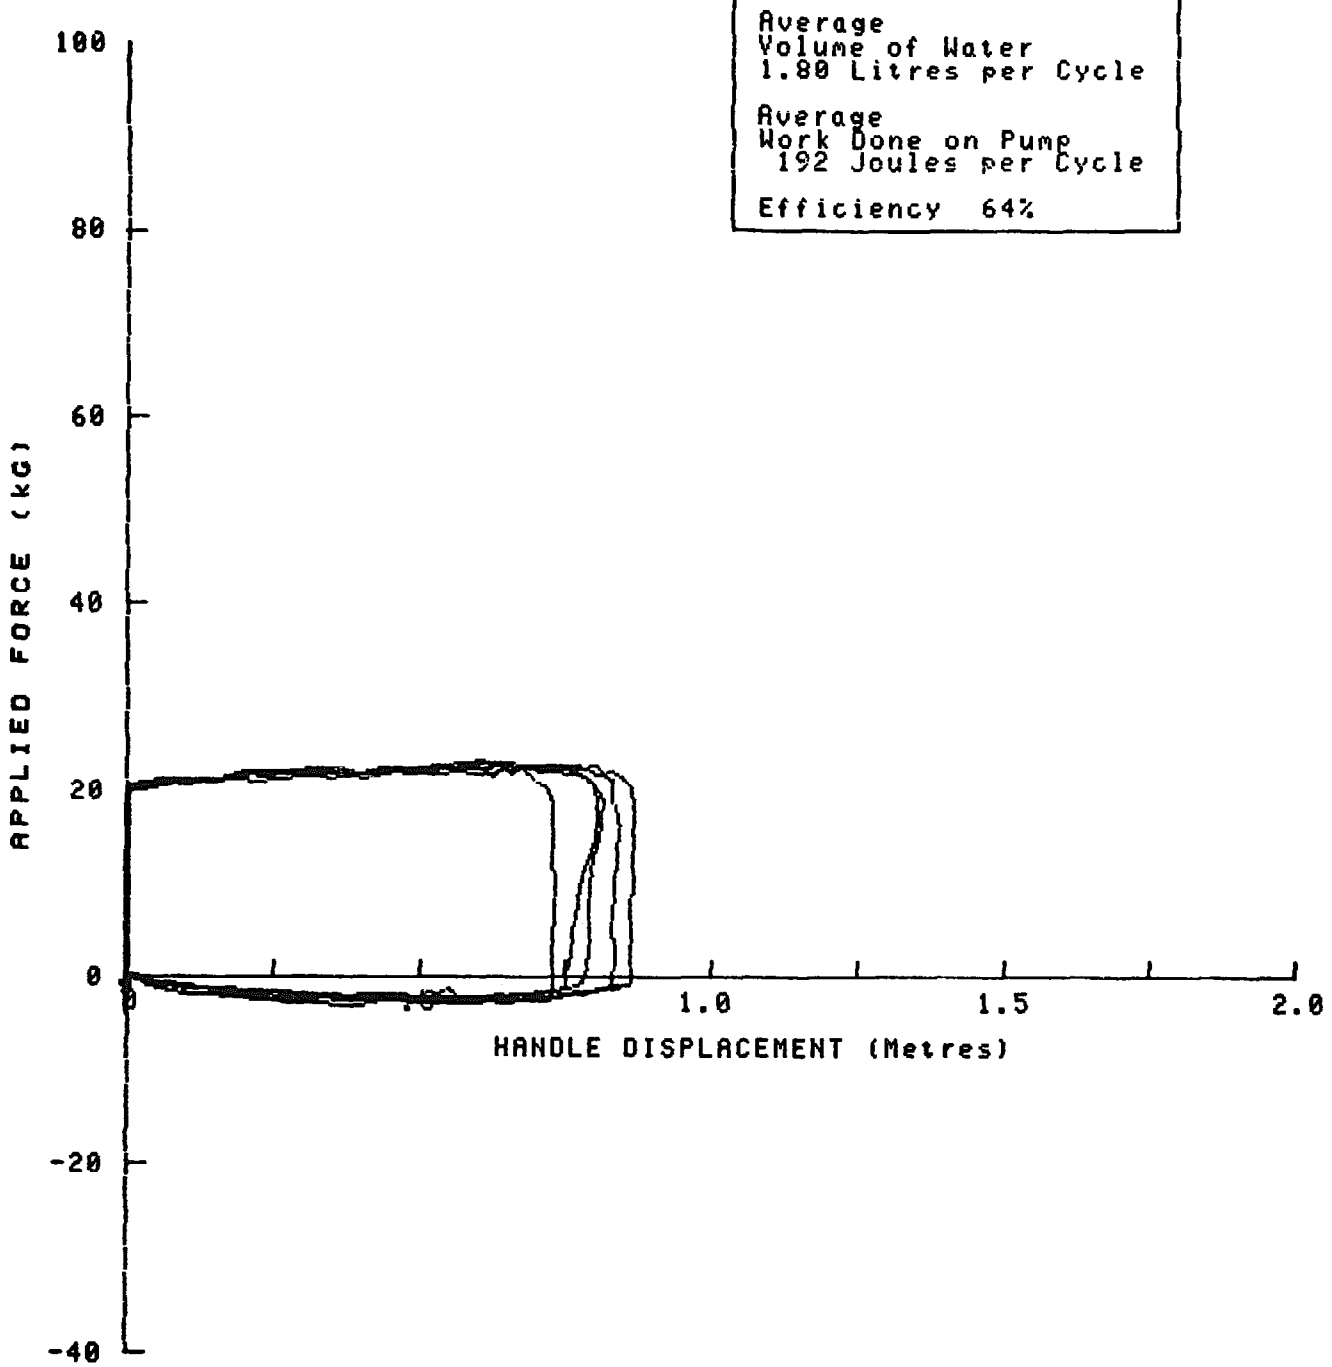
PUMP PERFORMANCE

A marginal reduction in efficiency can be seen when the surge chamber is not used.

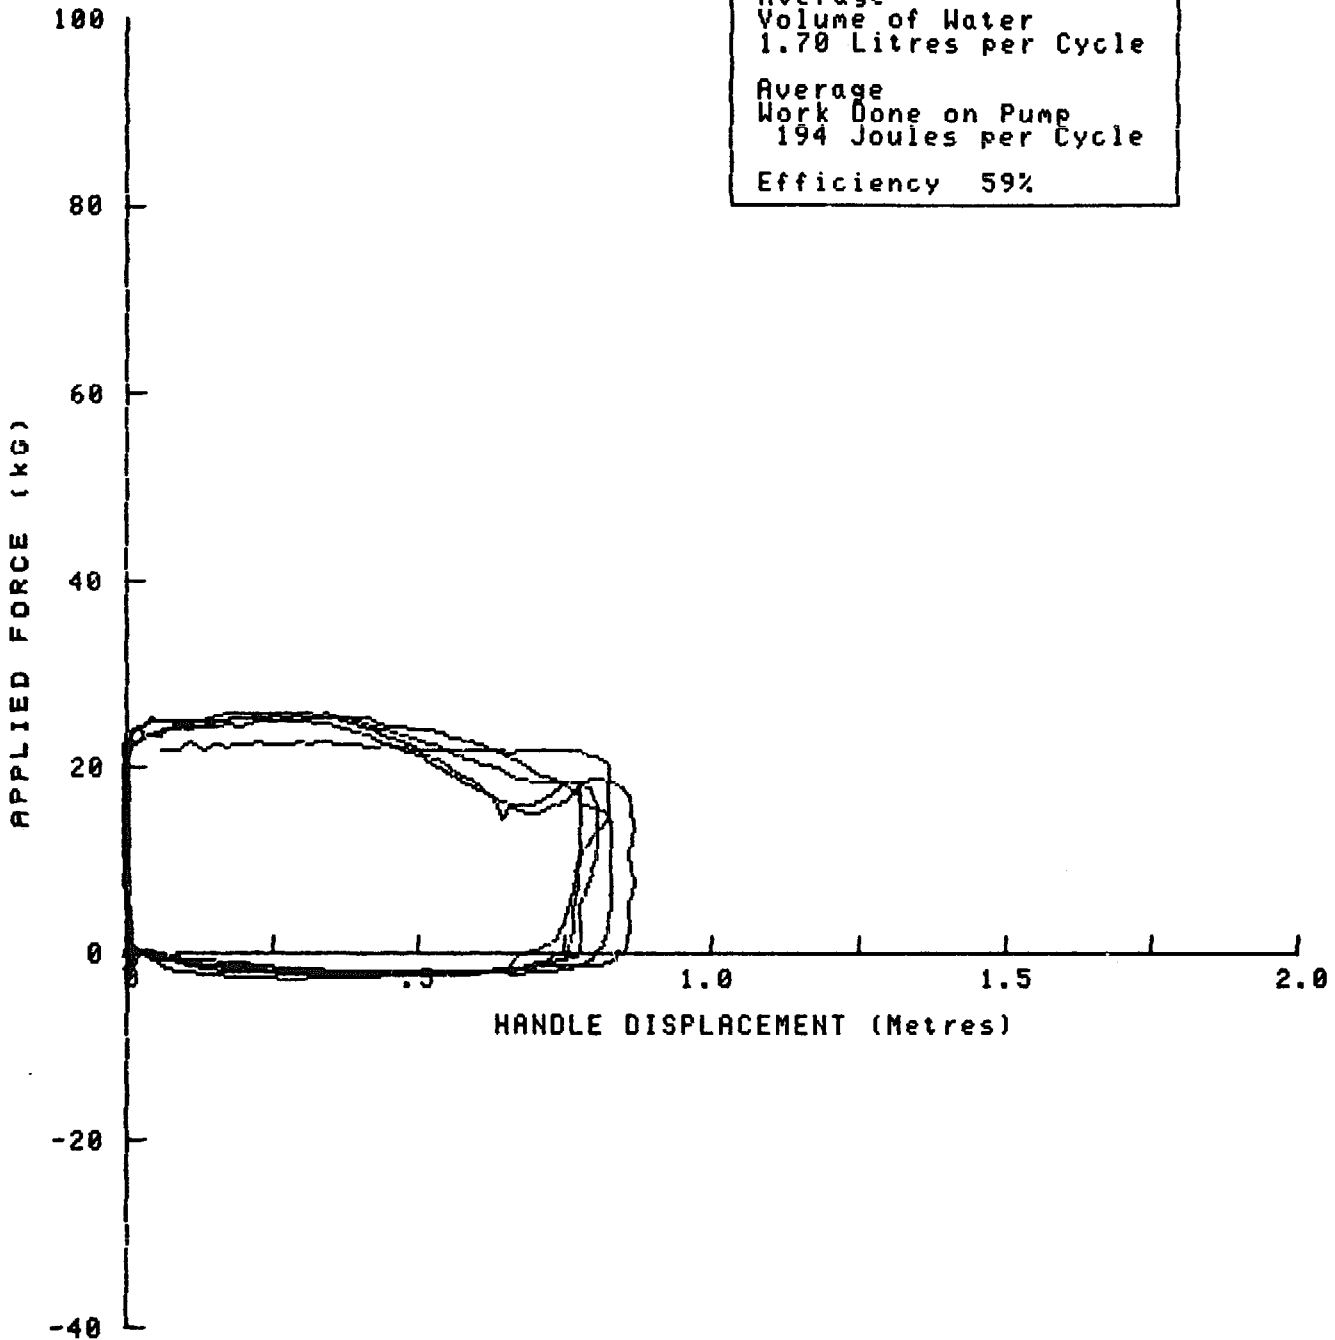
PUMP PERFORMANCE after endurance CODE R Rower with Surge Chamber

Considerably higher efforts were noted after endurance, possibly due to increased friction between the cup seal and cylinder bore.

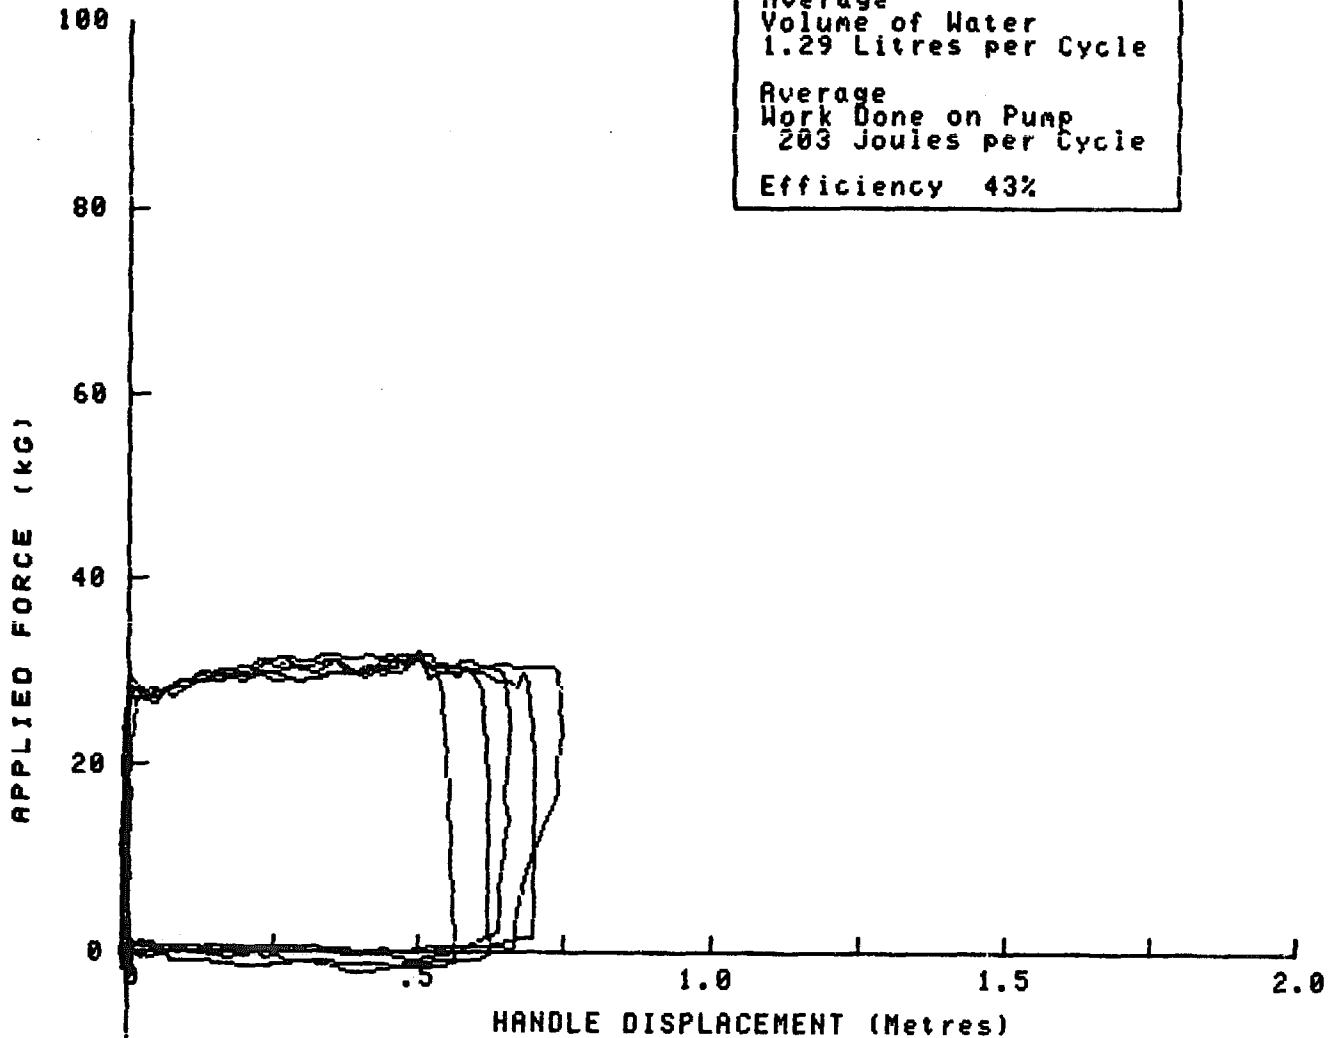
By limiting the test to 9 revolutions the initial effort to start the pump from rest has reduced the average efficiency. This would be higher if the test was carried out over a larger number of revolutions.

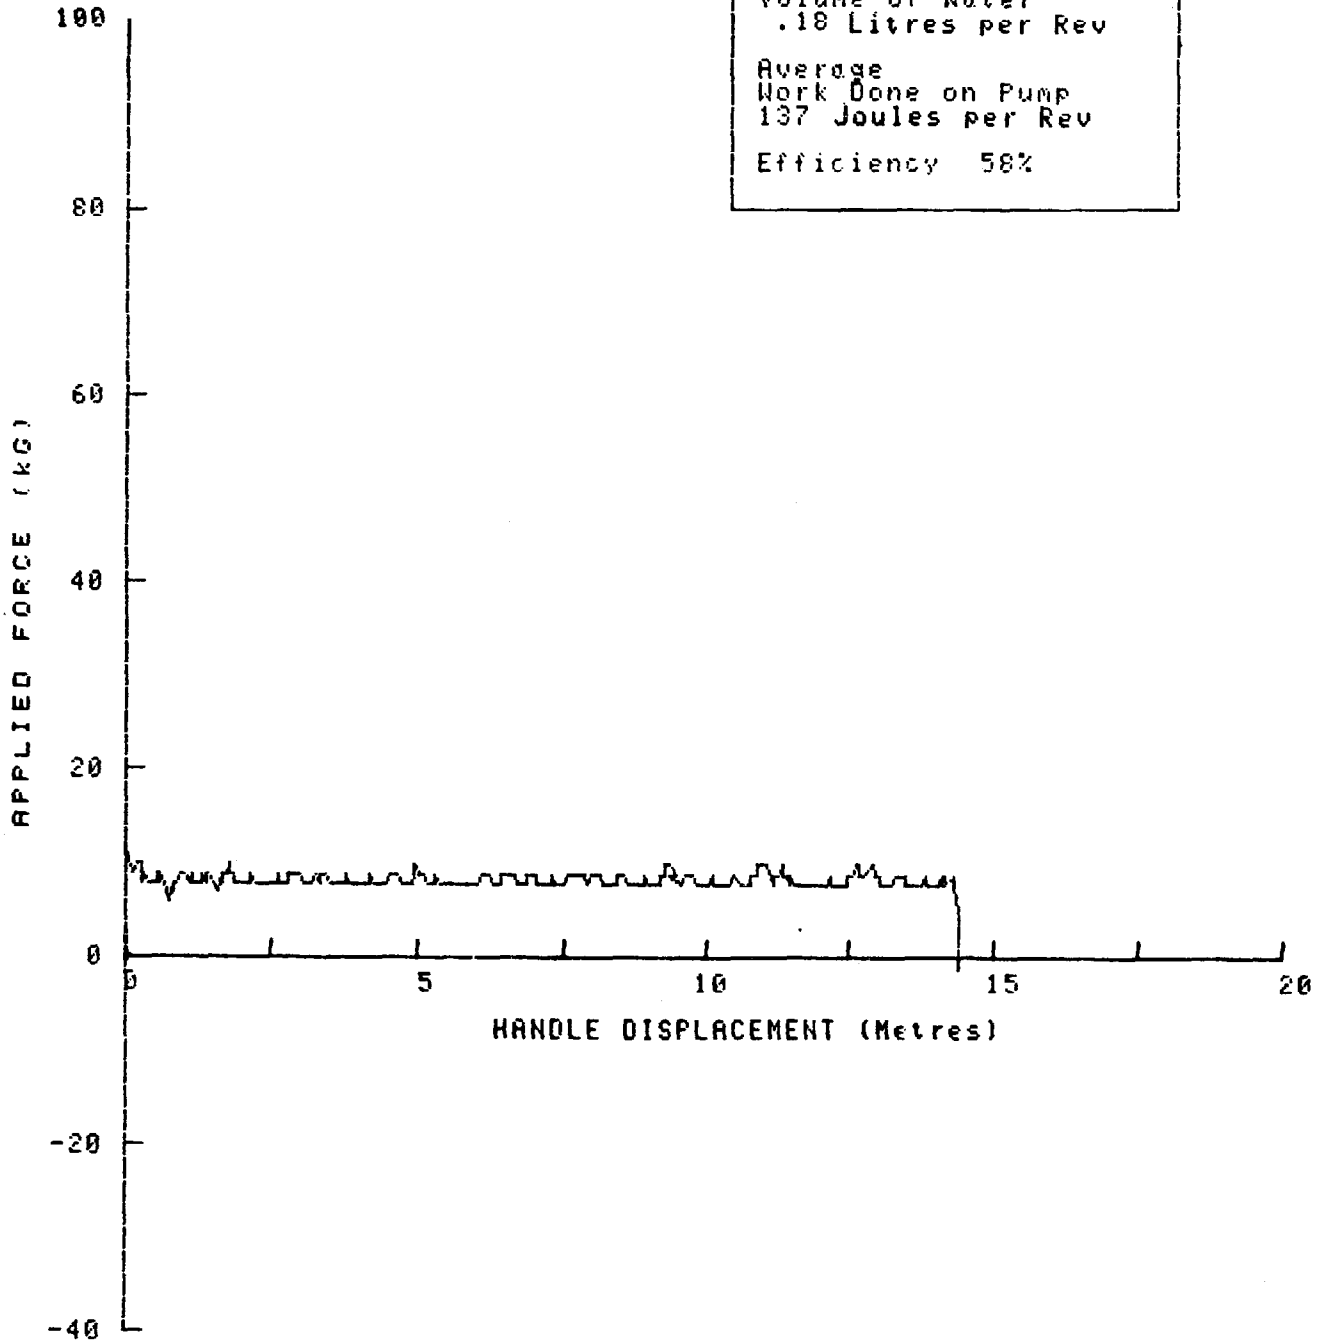
The irregularities on the curves are probably due to system noise.

The diagrams indicate a reduction of friction combined with an increase in volume flow.

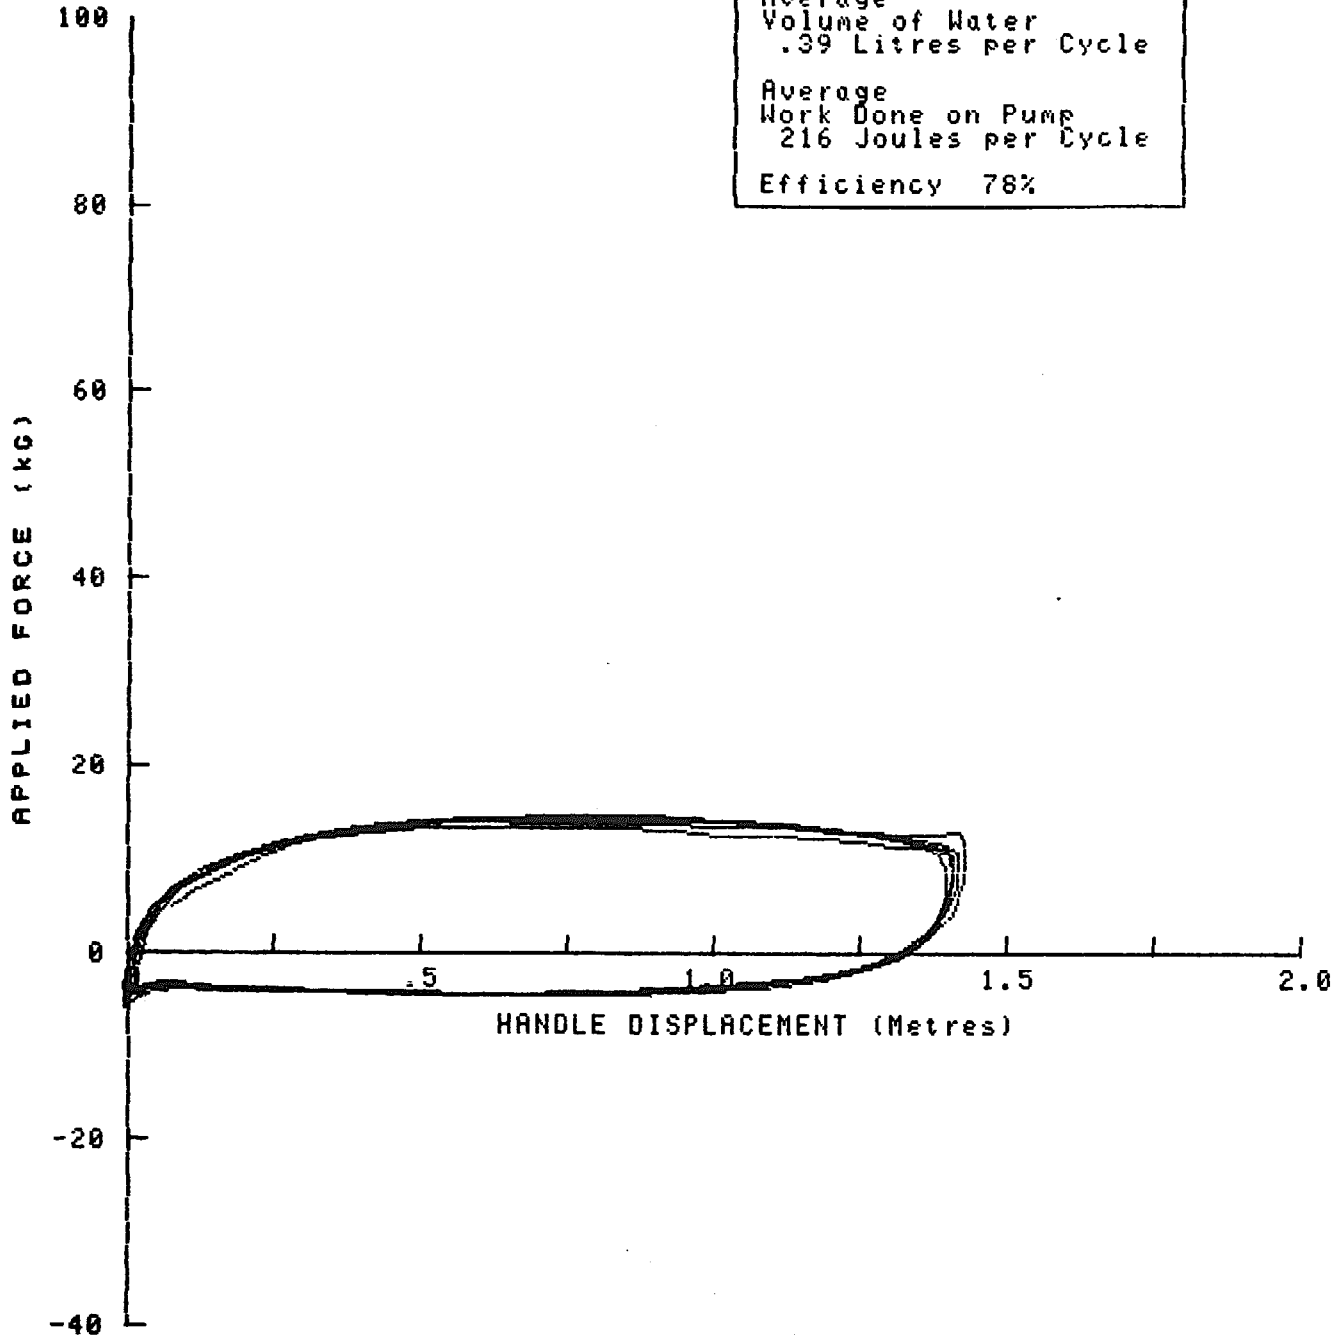
The results show that the work done on the handle increased by over 50% after endurance, with a small increase in volume flow. Friction had therefore increased considerably, probably as a result of the failure of the upper plunger seal.

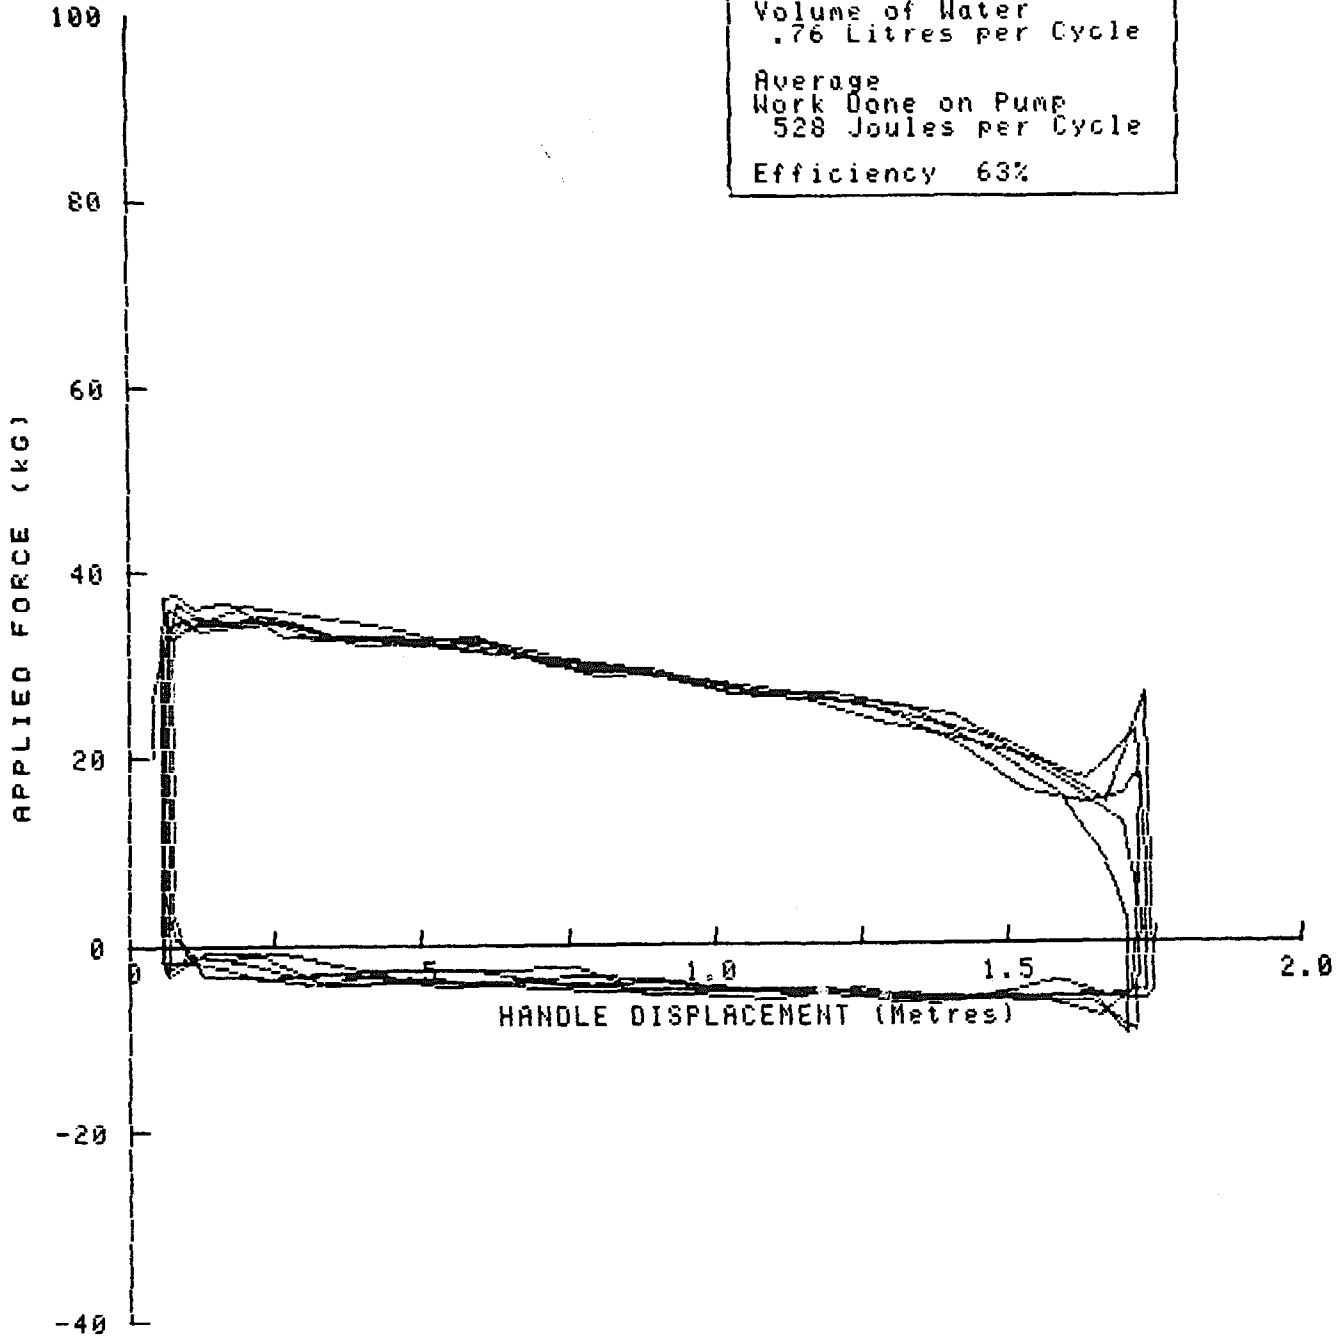
Differences between the profiles of the curves before and after endurance are the result of severe wear at the handle pivot.

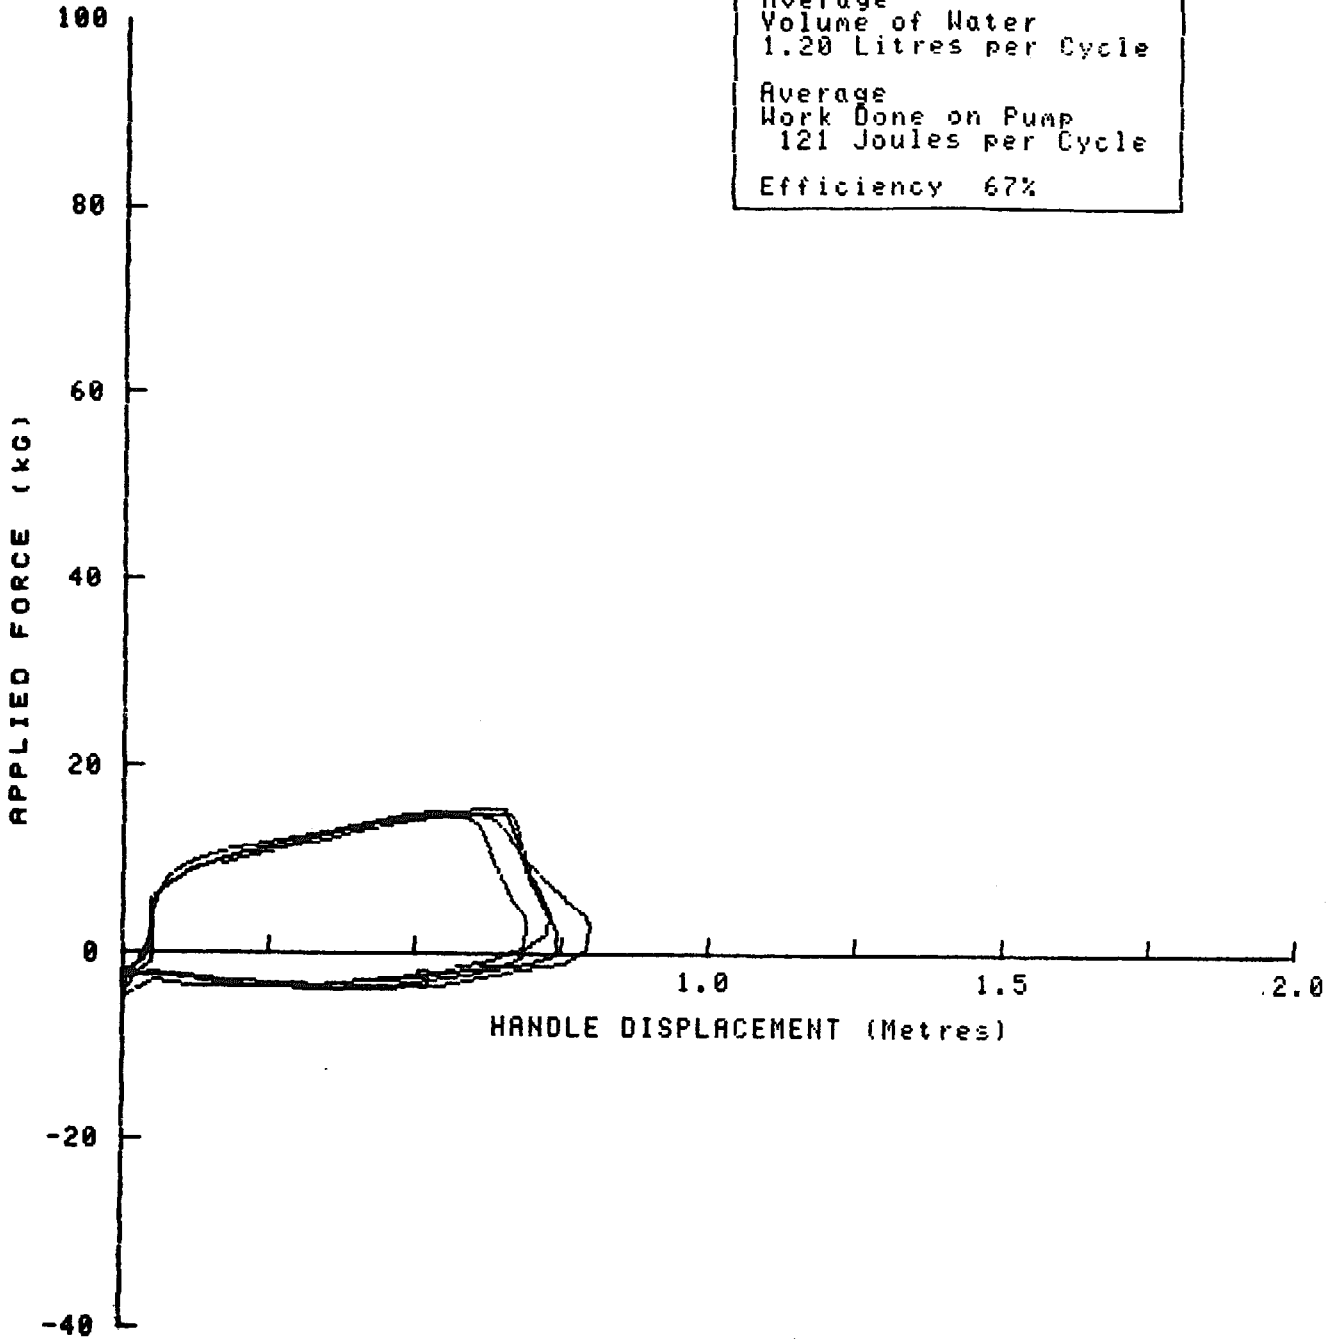
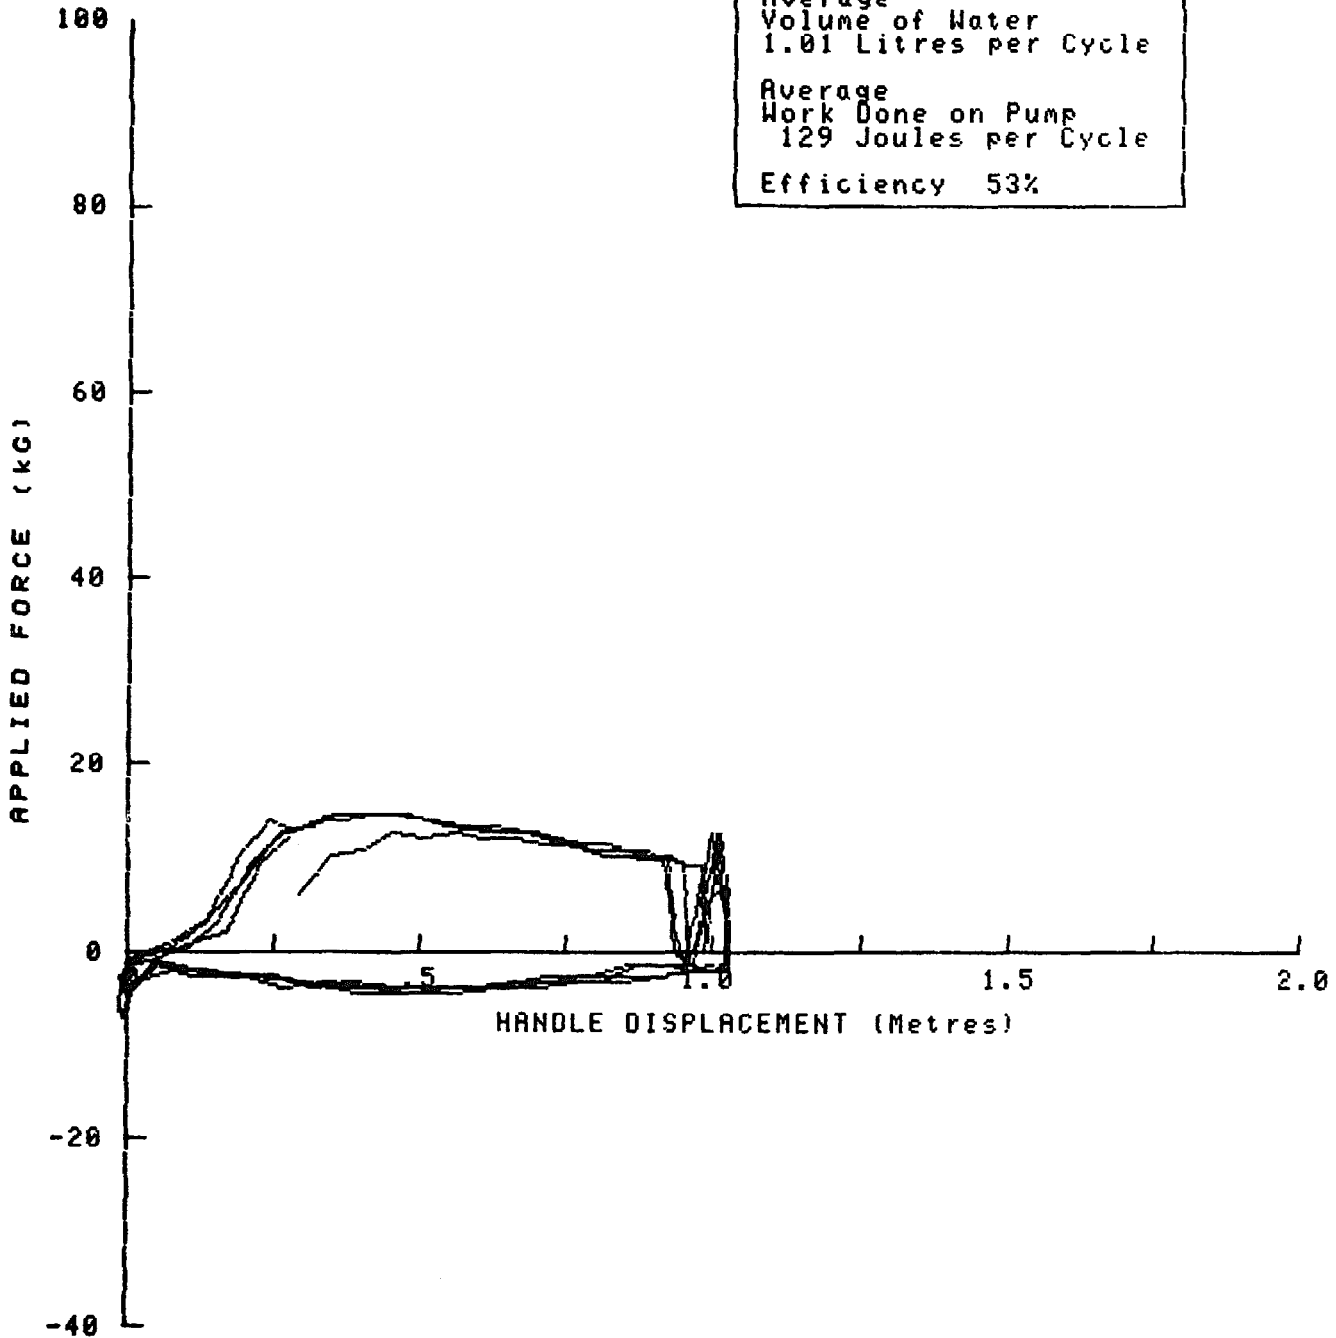
Differences between the profiles of the curves before and after endurance illustrate increased lost motion in the handle pivots.

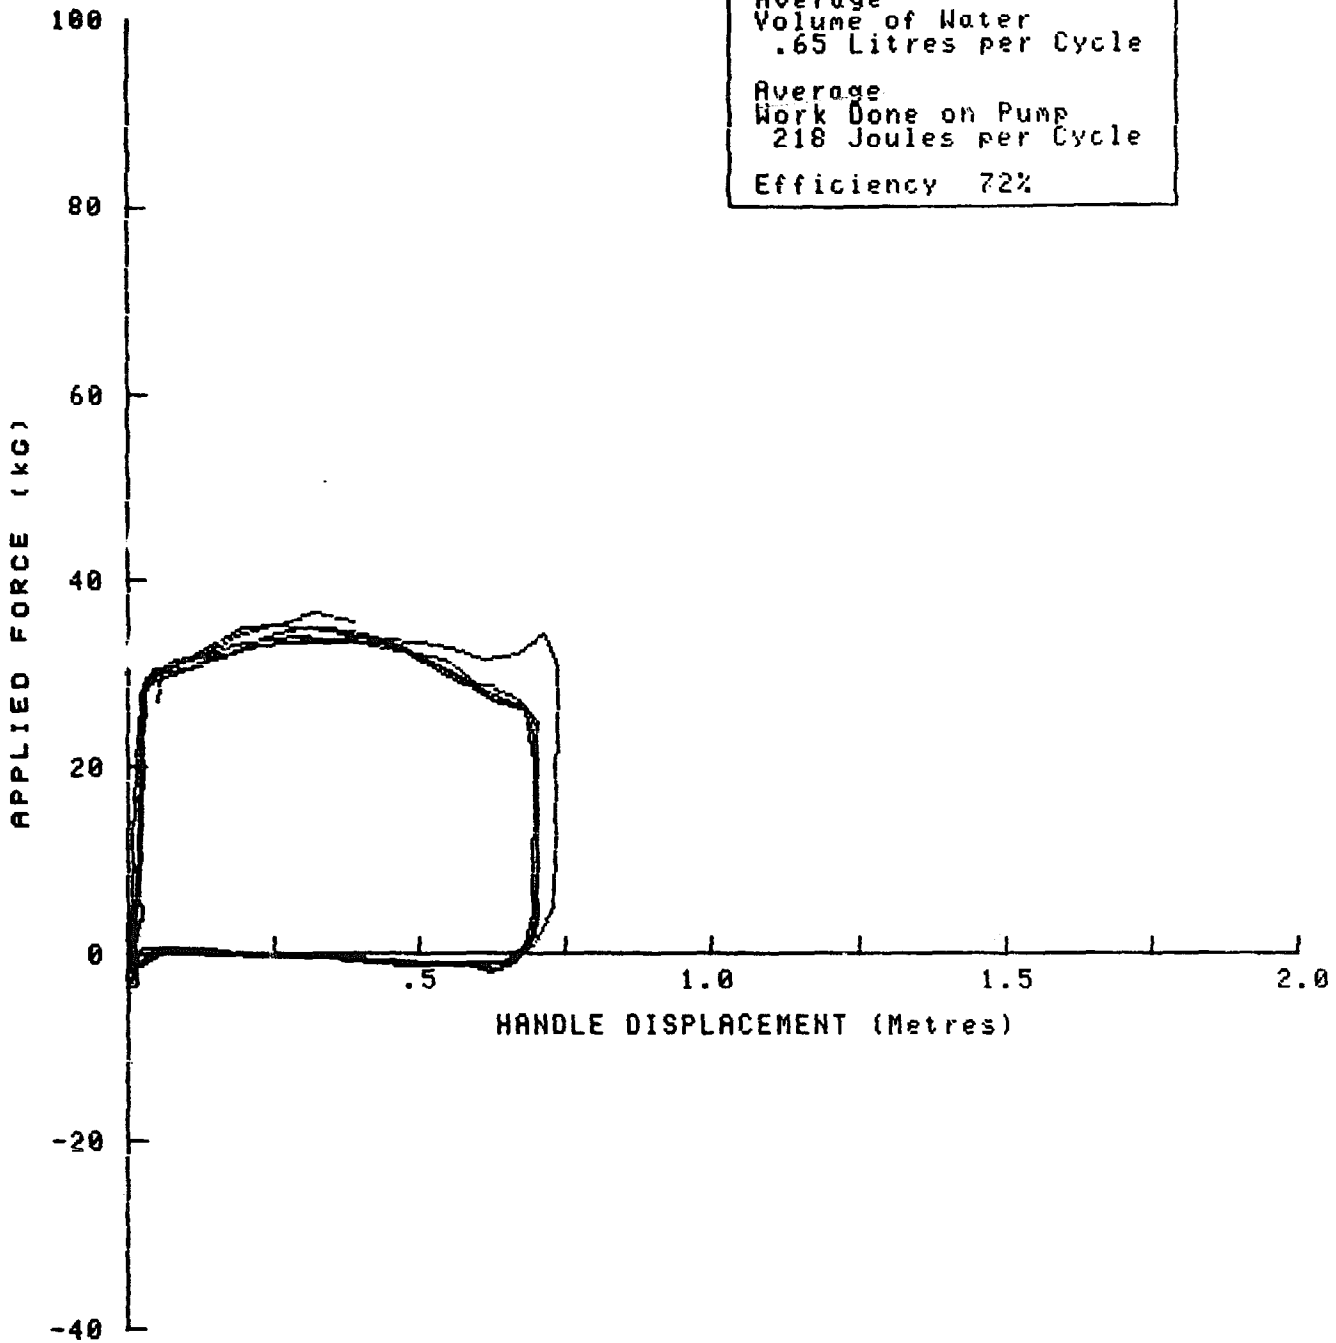
Differences in the profiles of the curves at the beginning of the delivery stroke, and the reduction of effort on the return stroke, probably illustrate the improved conformity of the rubber cup washer after bedding in.

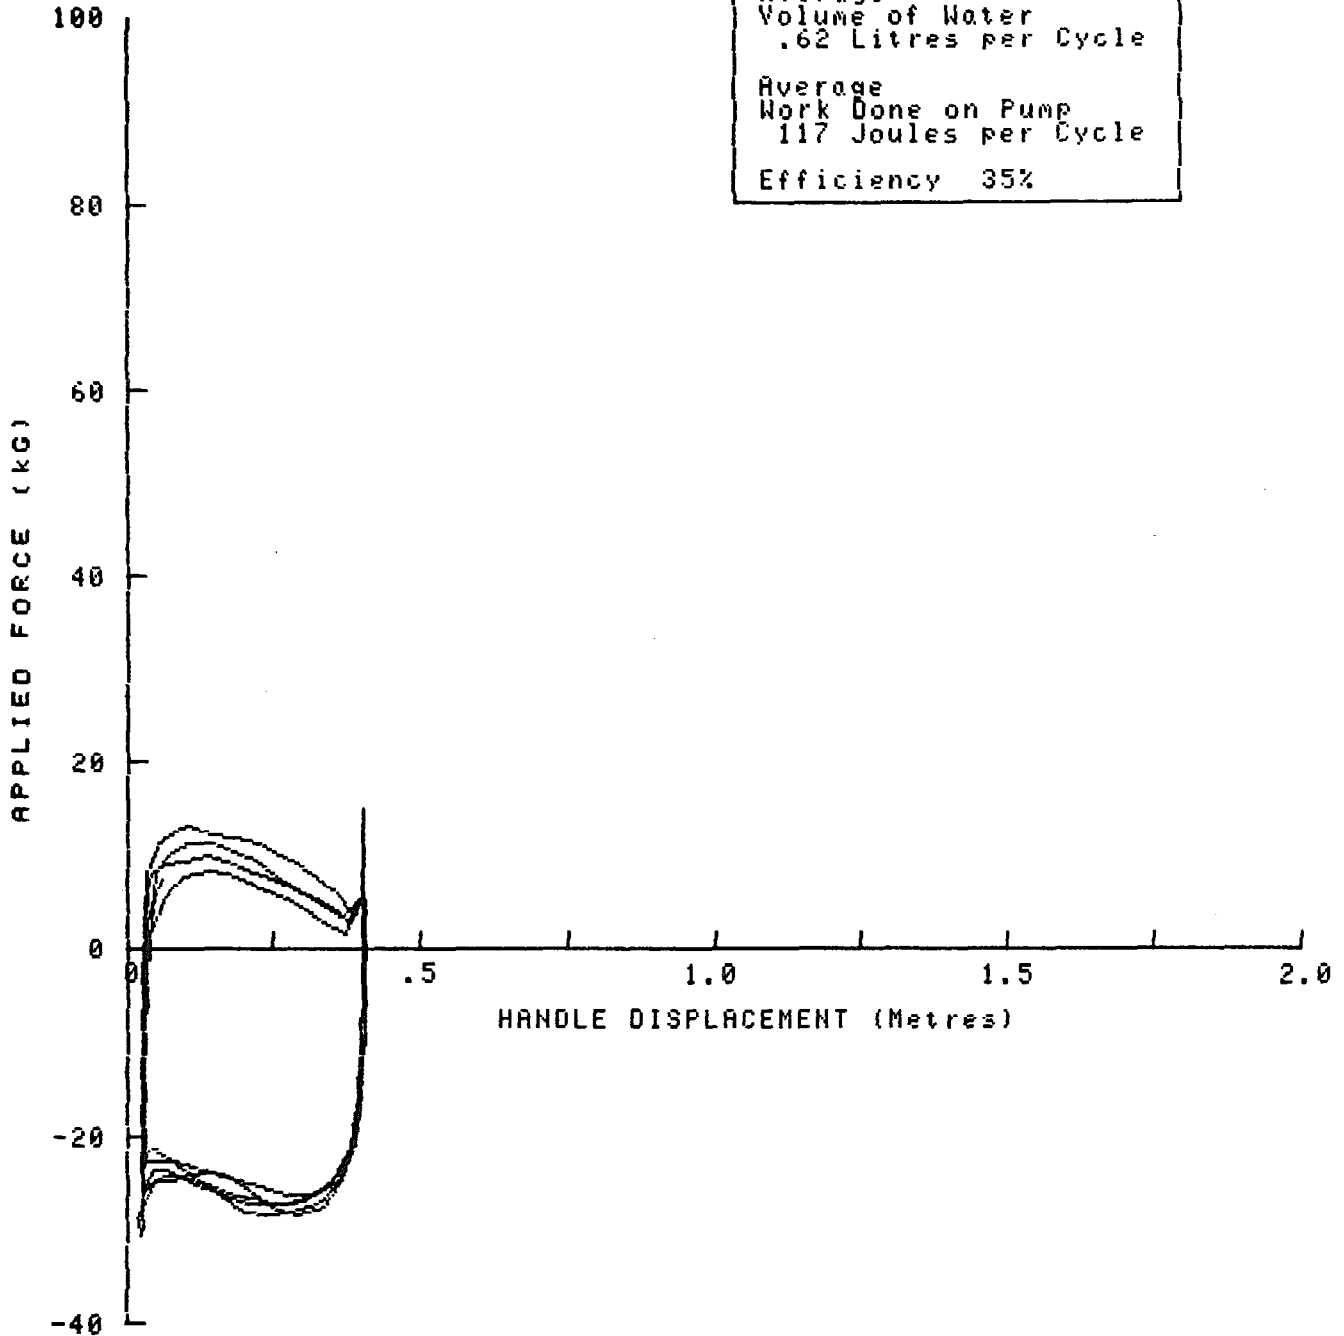
As this pump discharges on the lifting stroke, the power stroke is below the horizontal coordinate. The reduction in force on the power stroke after endurance shows the leakage past the plunger.

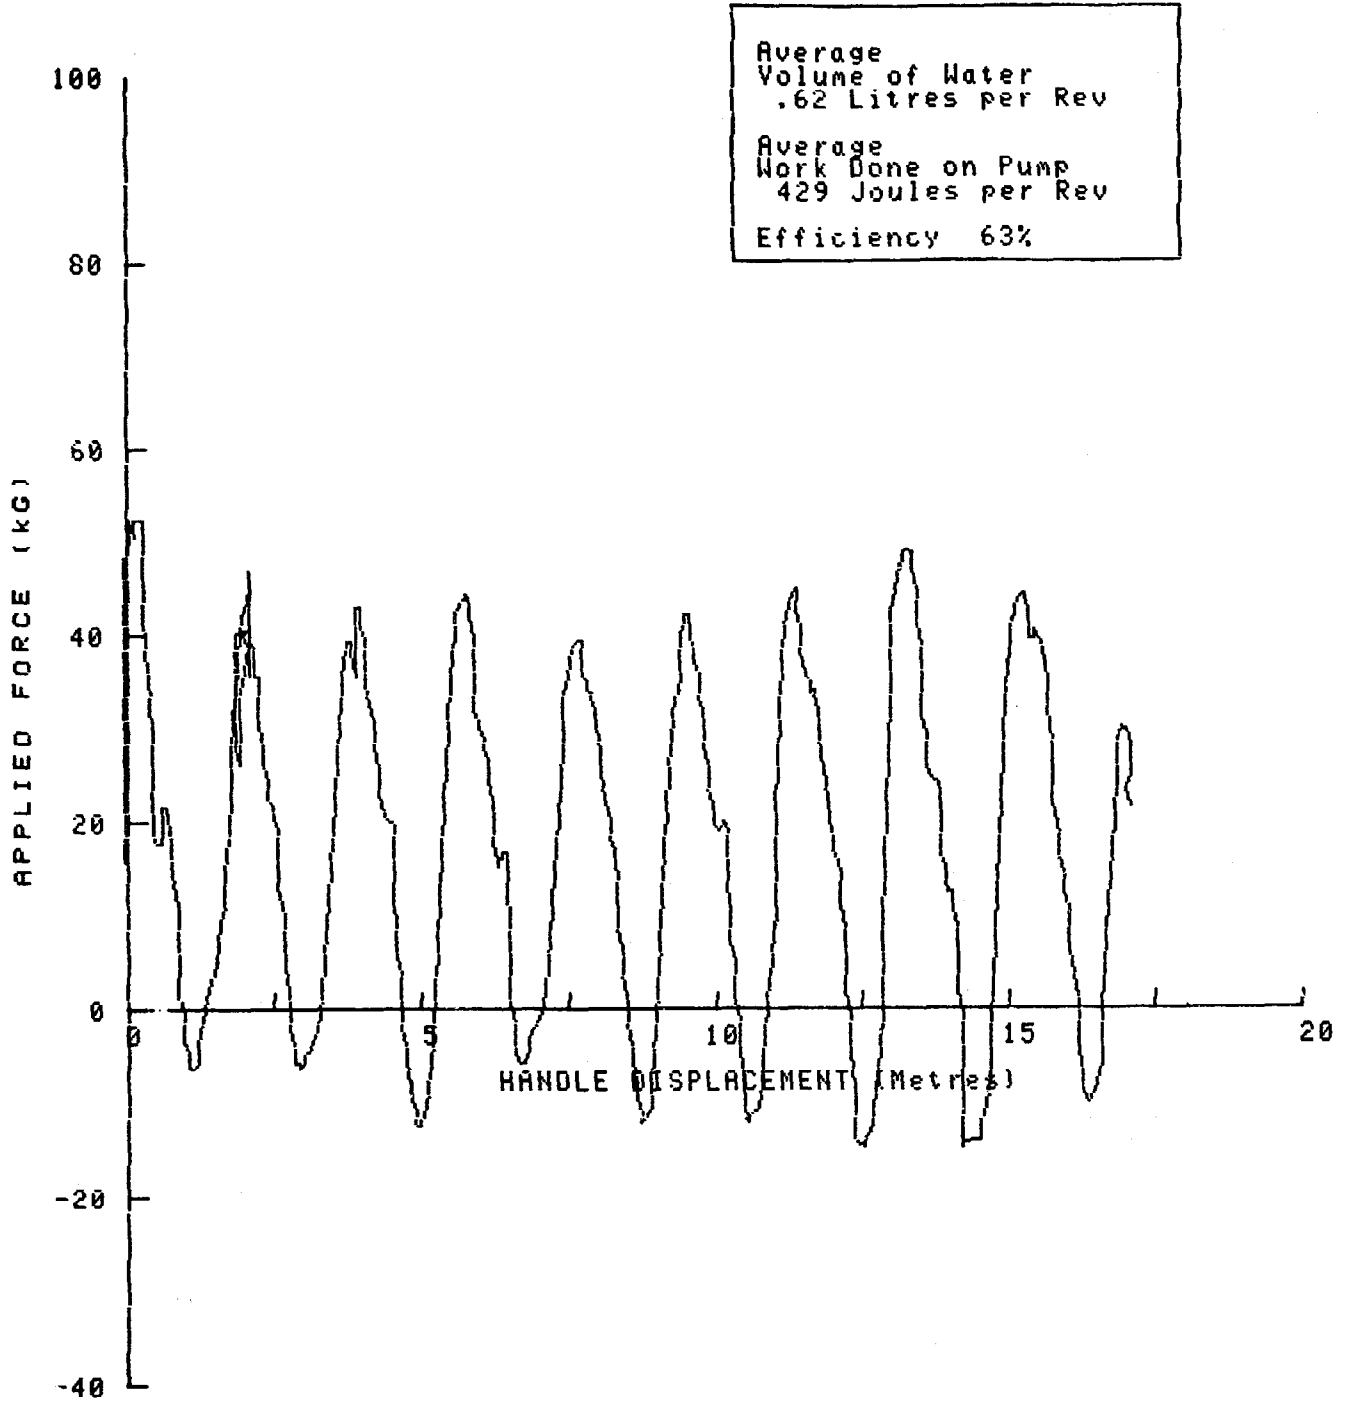
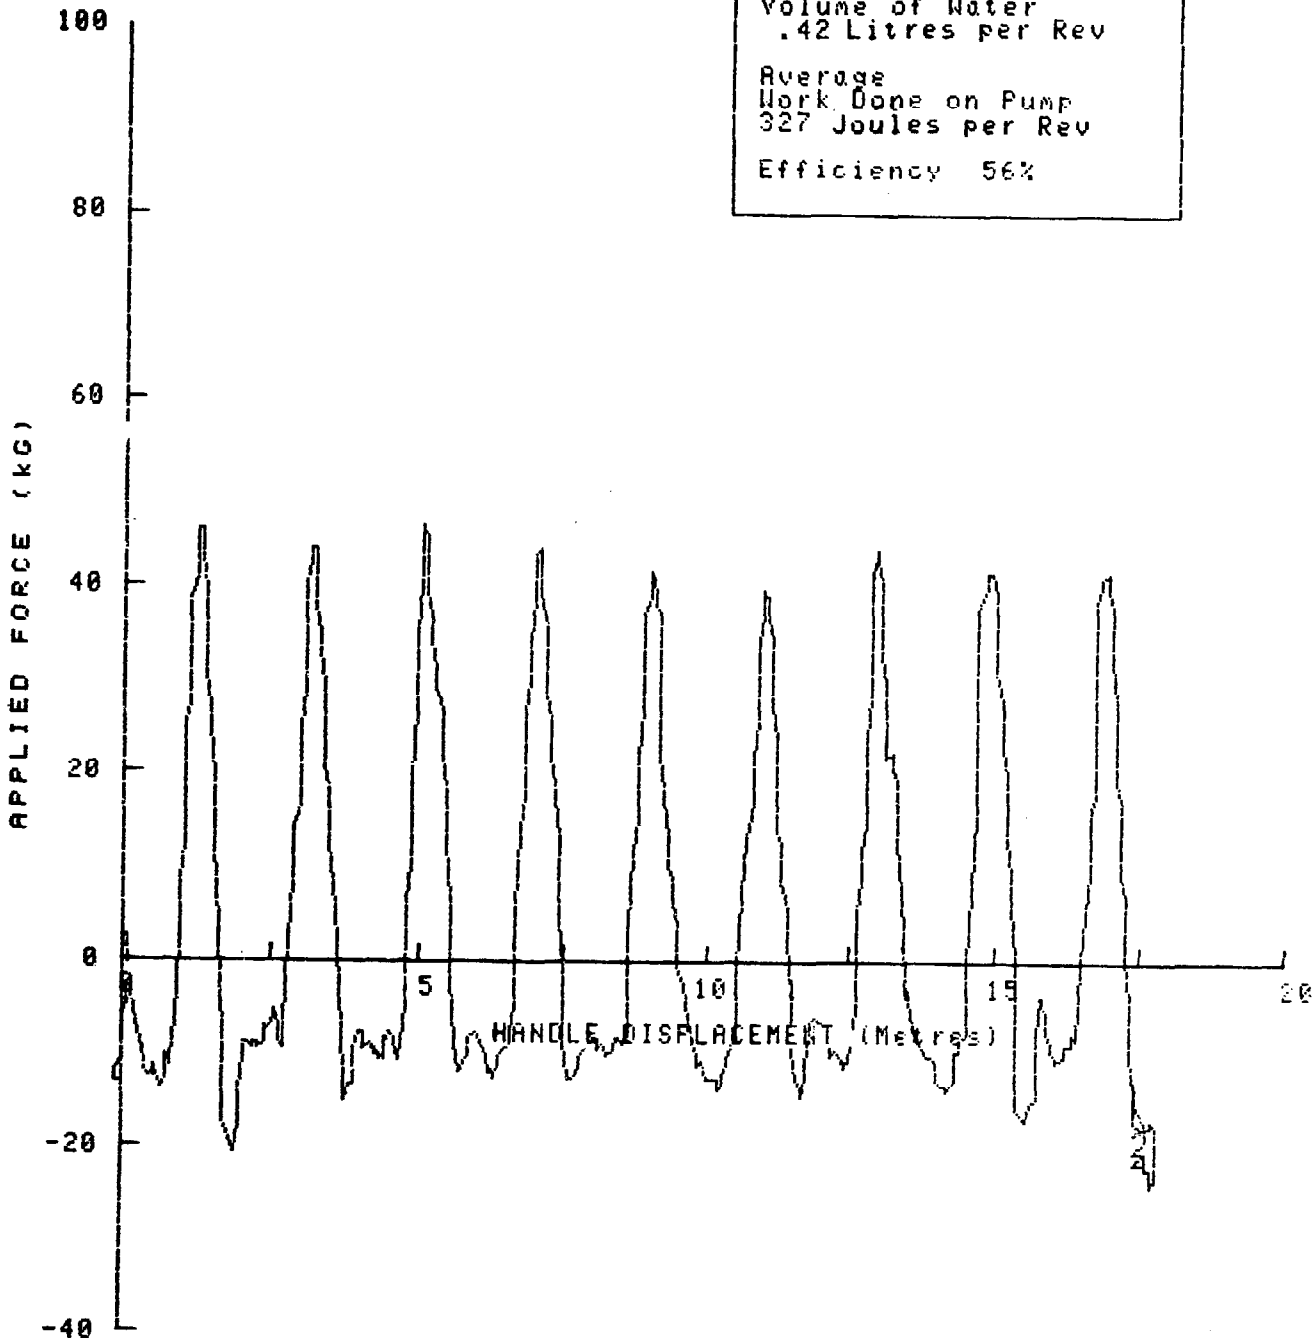
The results before and after endurance should not be directly compared because the plunger seal was replaced during the endurance test. Differences in the profiles of the curves may also reflect the changed position of the handle counterweights.
