Laboratory Testing of Handpumps for Developing Countries,
World Bank Technical Paper #19 from the Rural Water
Supply Handpumps Project

Rural Water Supply Handpumps Project

Laboratory Testing of Handpumps for Developing Countries: Final Technical Report

Consumers' Association Testing and Research Laboratories

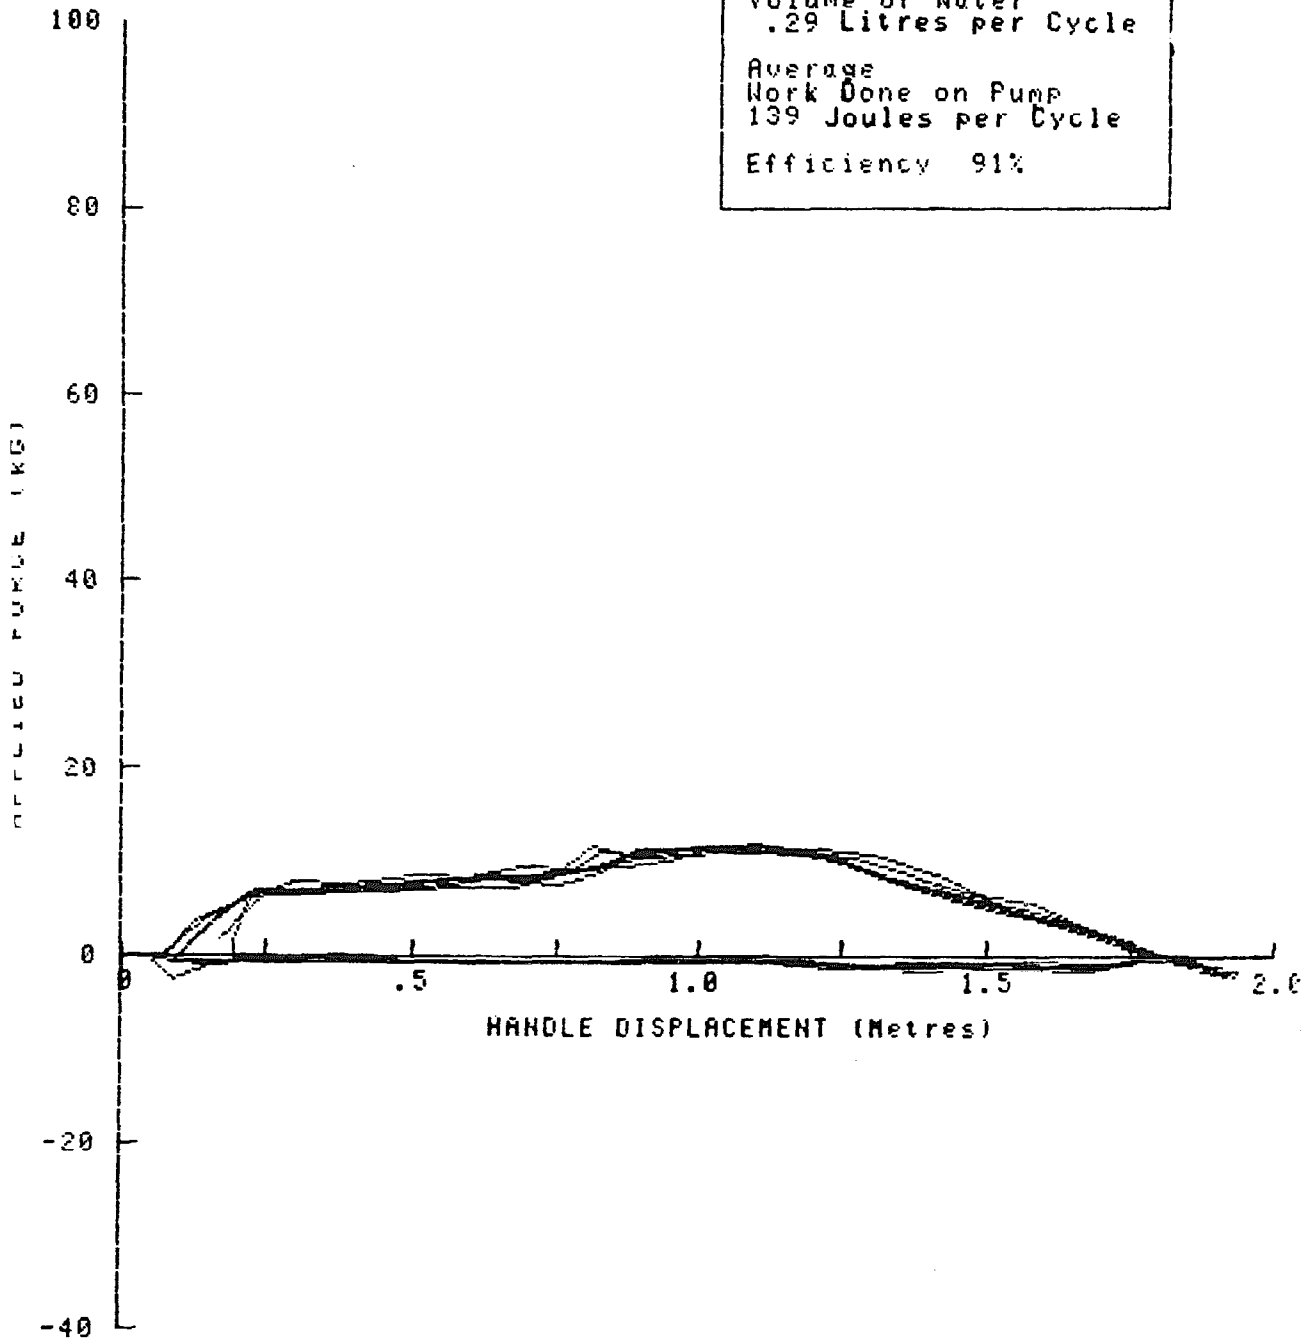
The results illustrate reduced friction after endurance testing.

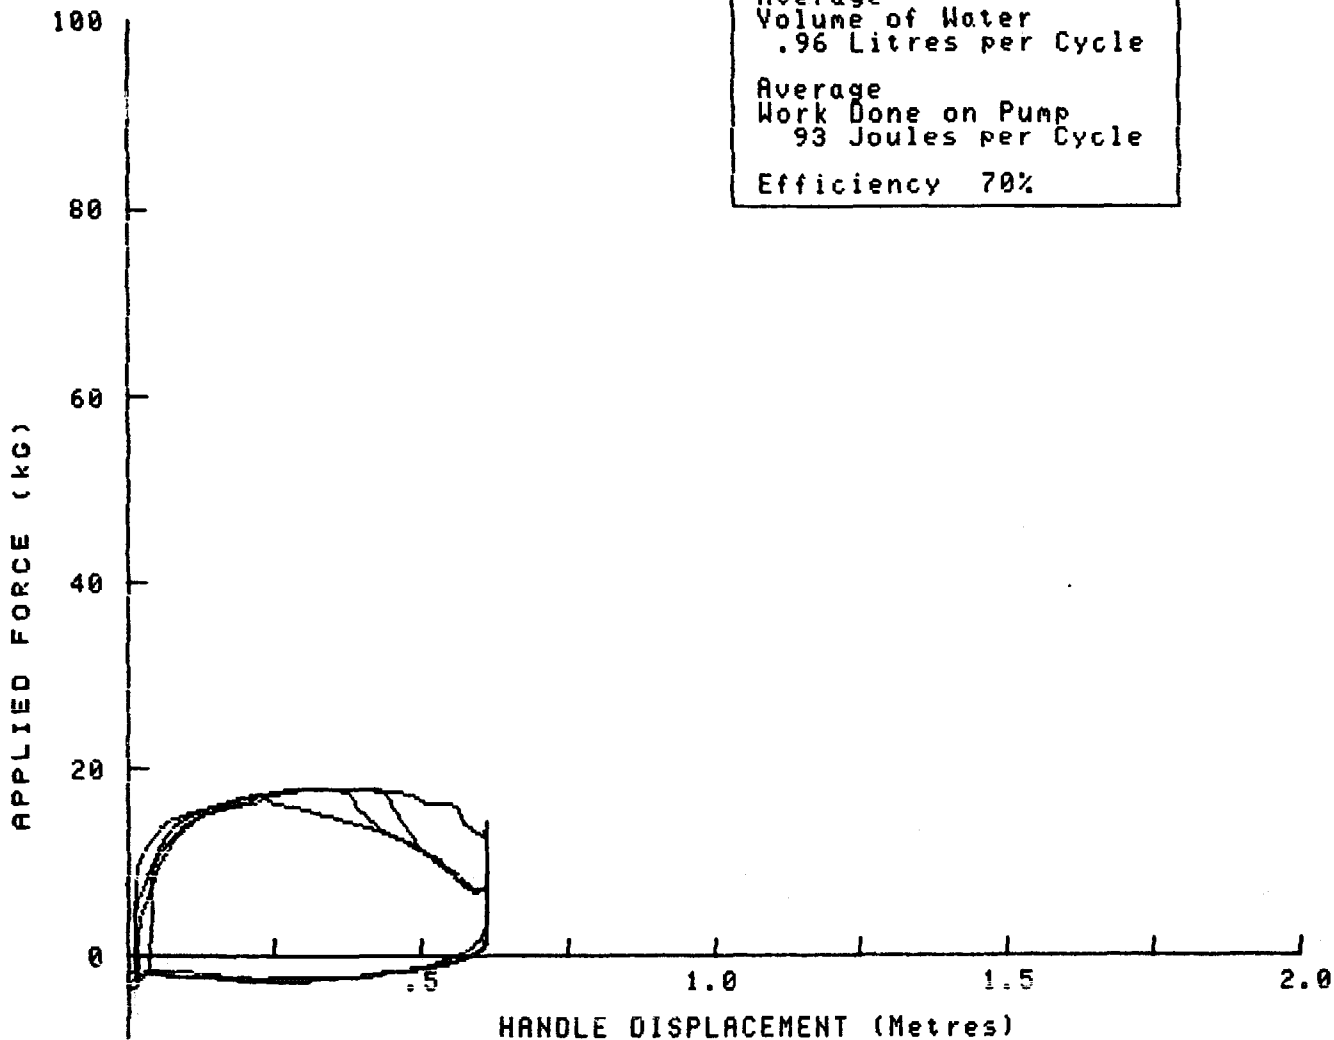
The results before endurance testing suggest some irregularities in the performance of the plunger seal or valve.

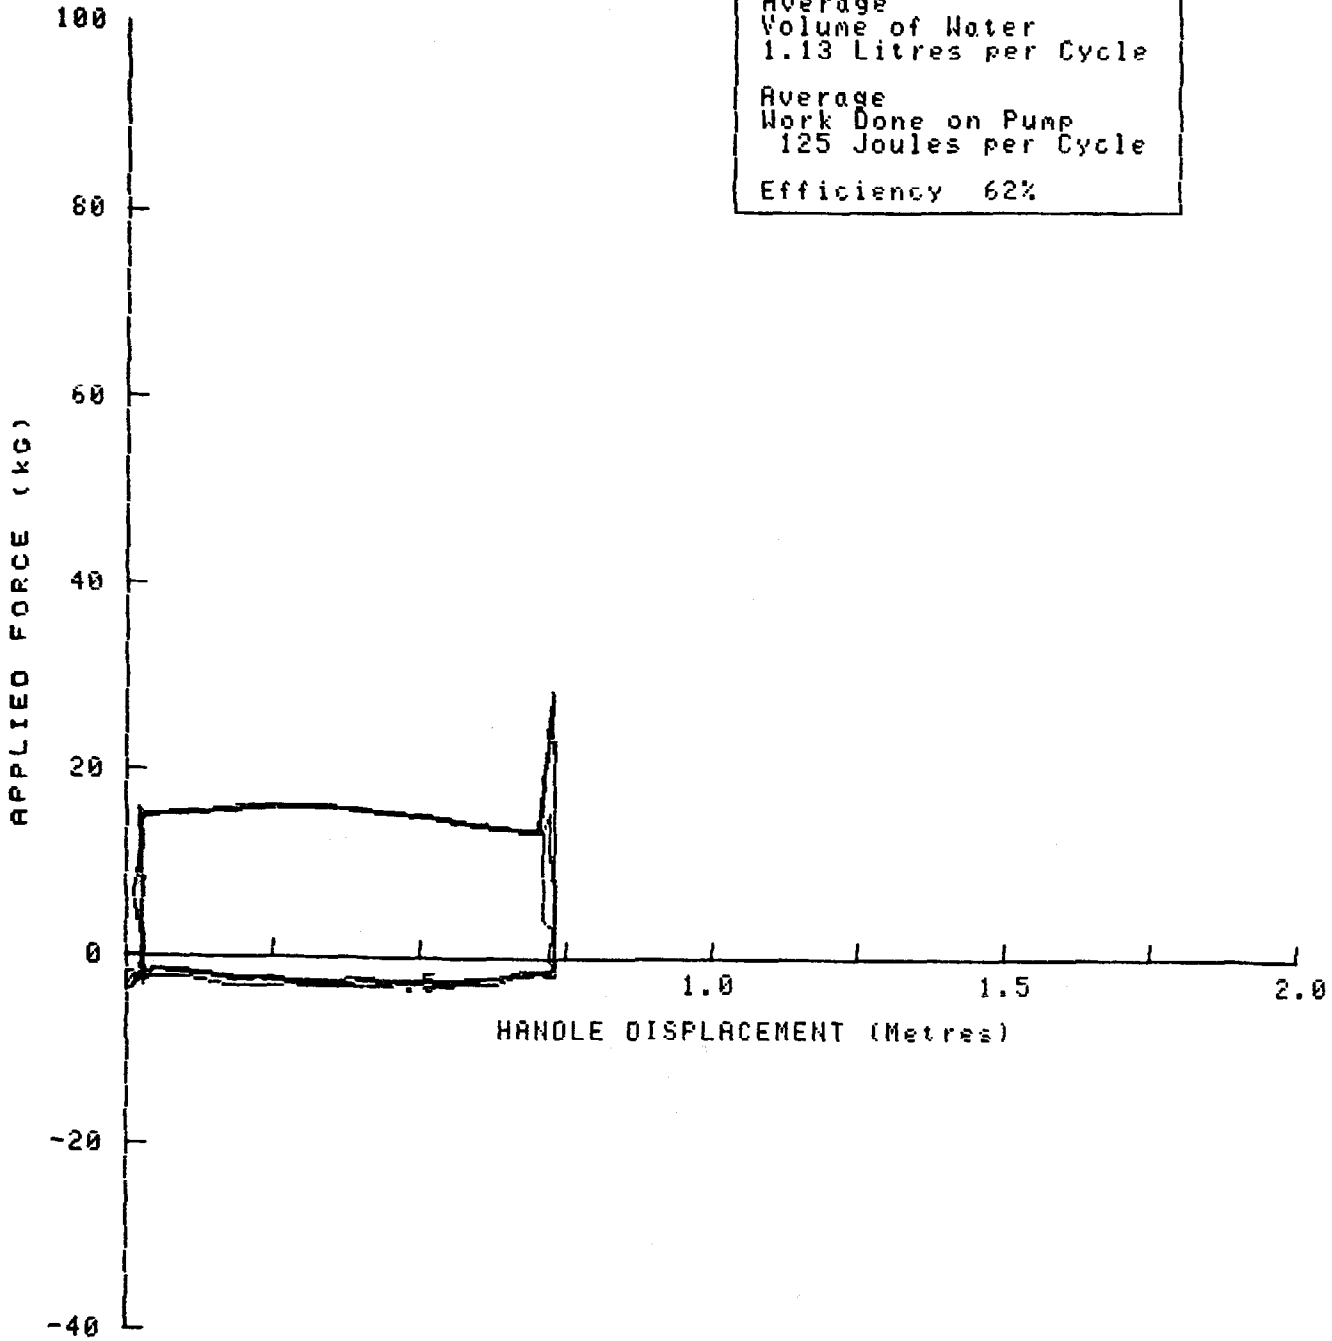
No irregularities are indicated, suggesting that the plunger seal and valve were working satisfactorily during this test. Note that the plunger seal was replaced three times during the endurance test.

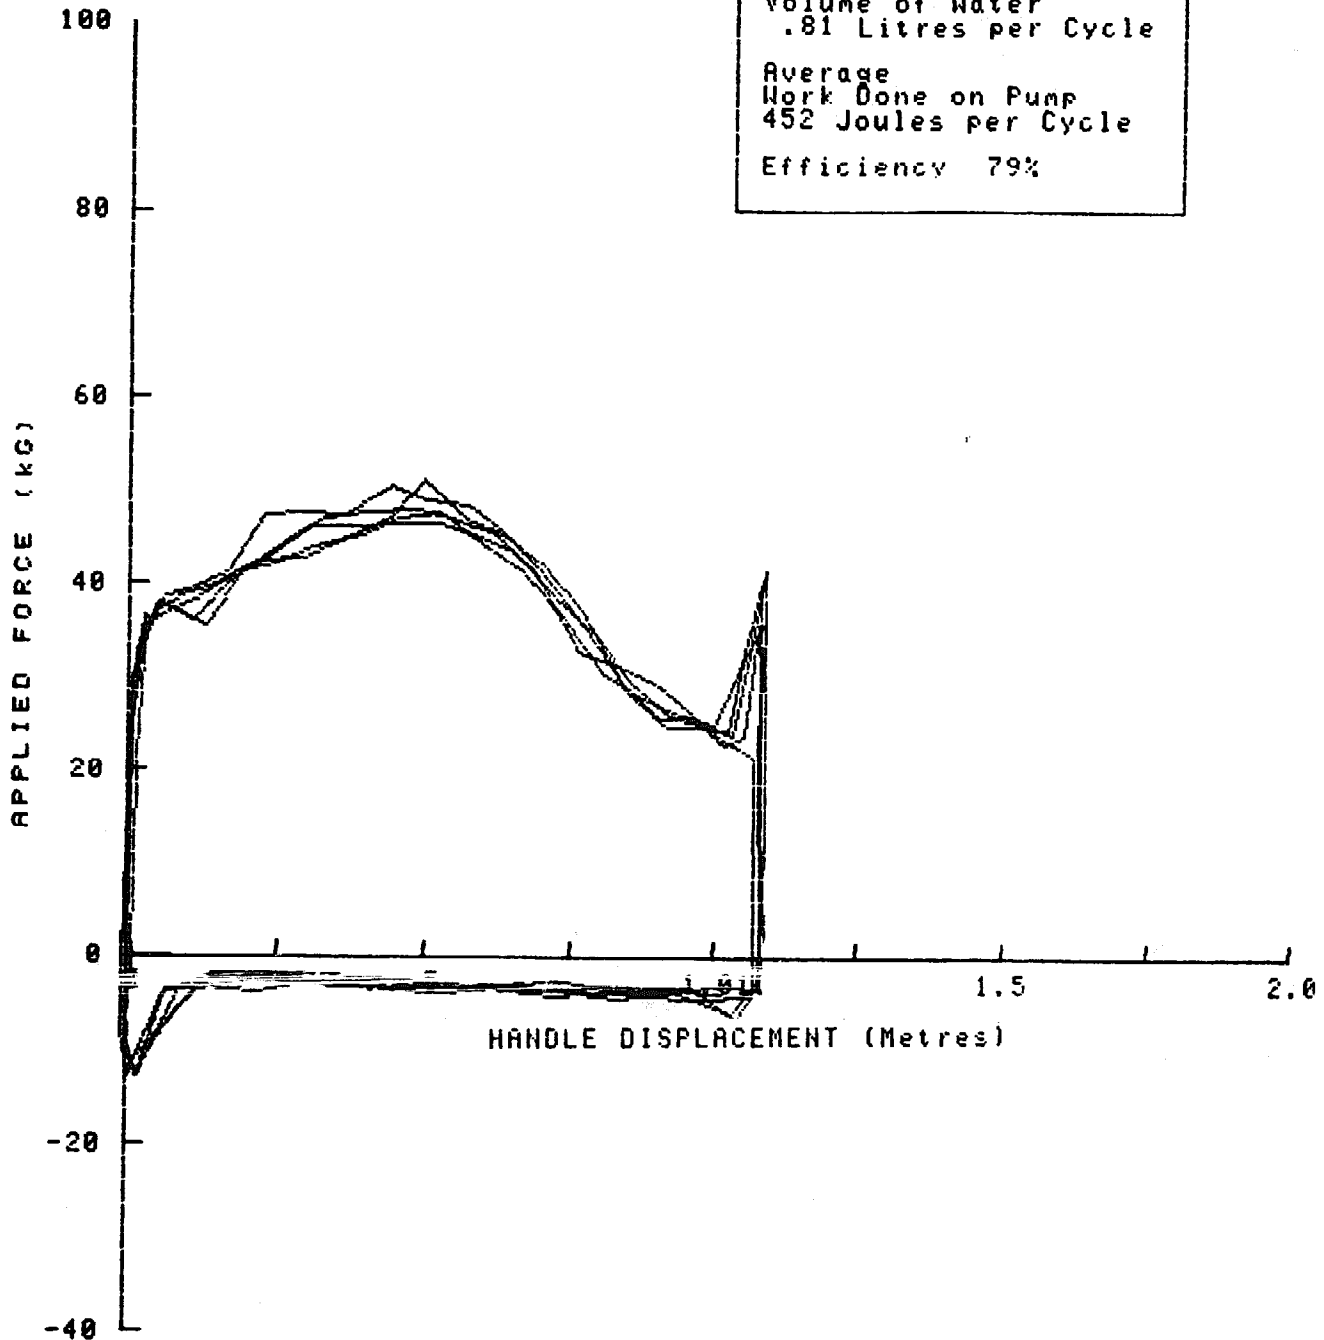
The results before and after endurance should not be directly compared because the cylinder components were replaced during the endurance test.
